GFA AIRWORTHINESS DIRECTIVE

TYPES AFFECTED: H 401 Kestrel
T59 Kestrel all variants
H301B Libelle
Standard Libelle
Standard Libelle 201B

SUBJECT: Cracking of the lower rudder hinge/control yoke.

TECHNICAL NOTE NO. 401 - 19

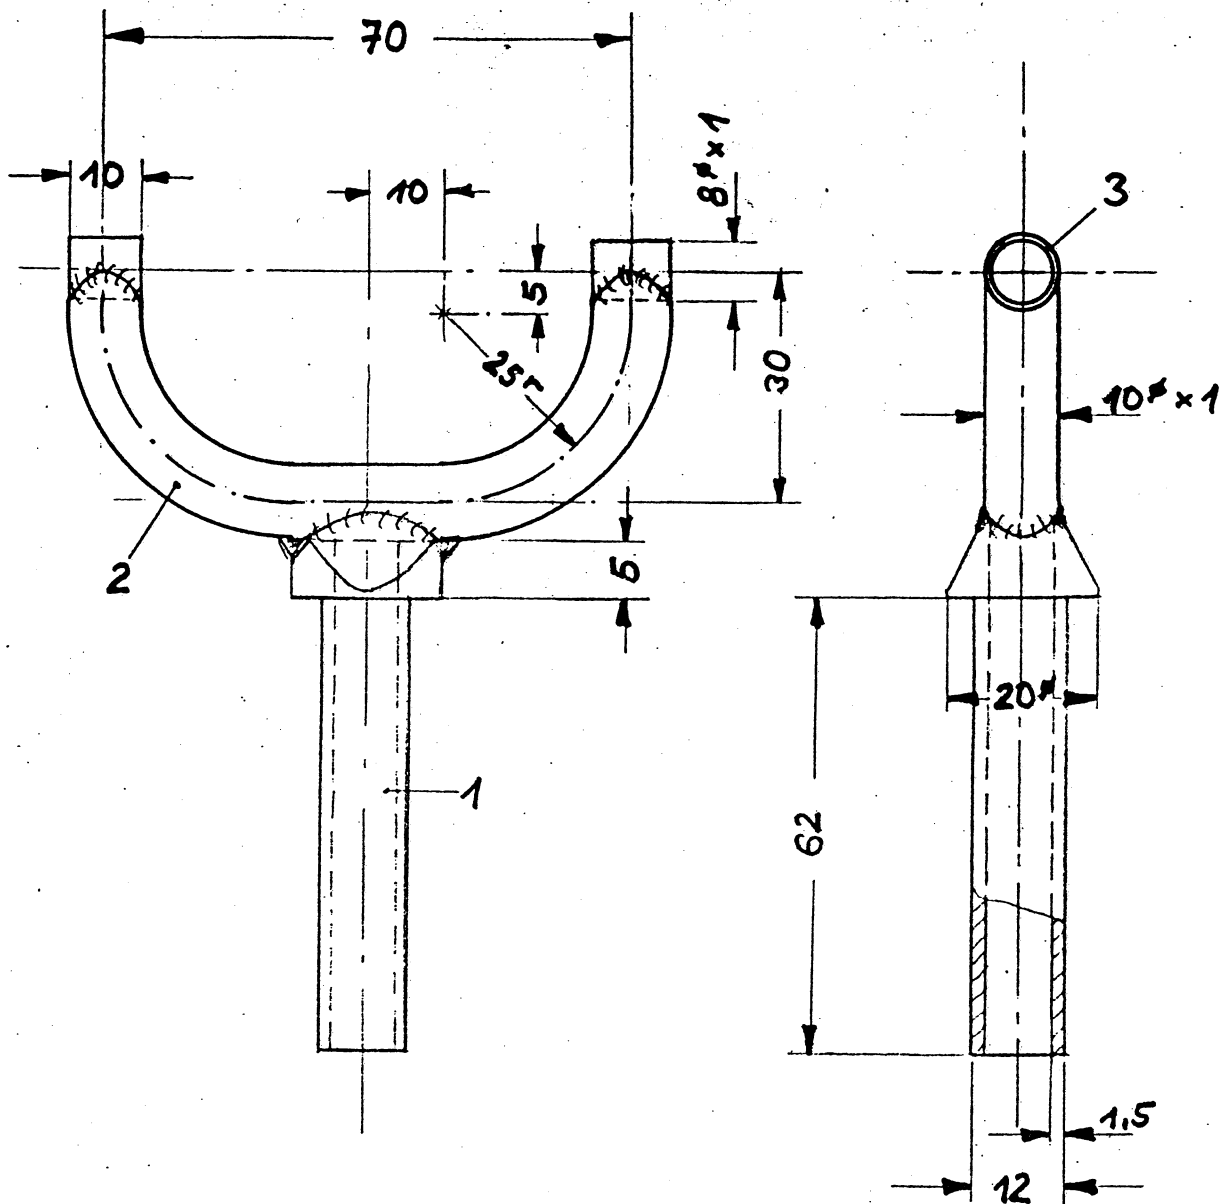
Im WIG-Verfahren mit Zusatzwerkstoff 1.7734.2 geschweißt. Grundiert mit Wash-Primer 42002 + Härter 40018. Decklackierung mit Nitro-Lack grau RAL 7003.

Spannungsfrei geglüht
bei 580°C 4 Std.
unter Schutzgas

Ruderlenker

Only genuine parts made in accordance with
drawing No. 301-45-13 must be used.

Actions : The faulty part, made according to drawing No. 301-45-10,
must be replaced by an improved actuator arm, made in
accordance with drawing No. 301-45-13.

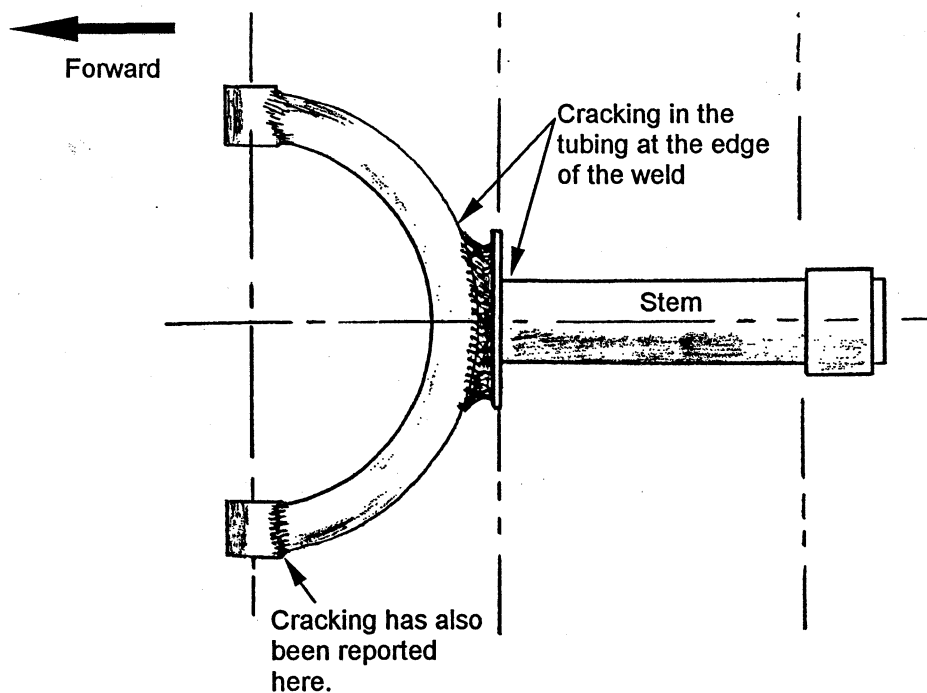
Reason : Failure of the actuator arm caused by loads applied
when regularly lifting the fuselage by its rudder.
and/or when fuselage has broken.

3. Types H 401 Kestrel and T59 Kestrel all variants must be fitted with improved actuator arm according to Technical Note No. 401-19.
