THE GLIDING FEDERATION OF AUSTRALIA

GFA AD/ 281

AIRWORTHINESS DIRECTIVE

Restrictions and modifications to reduce risk of elevator flutter.

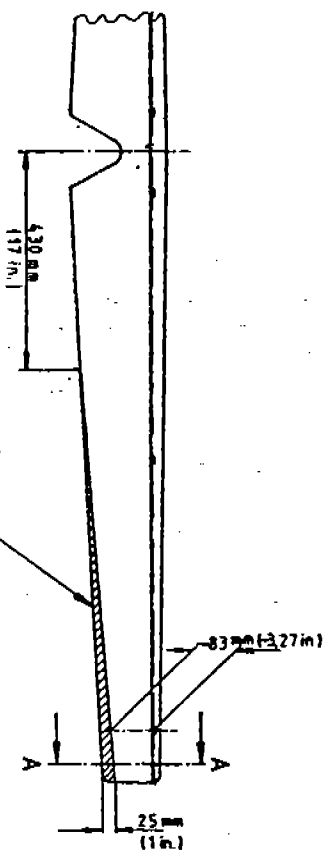
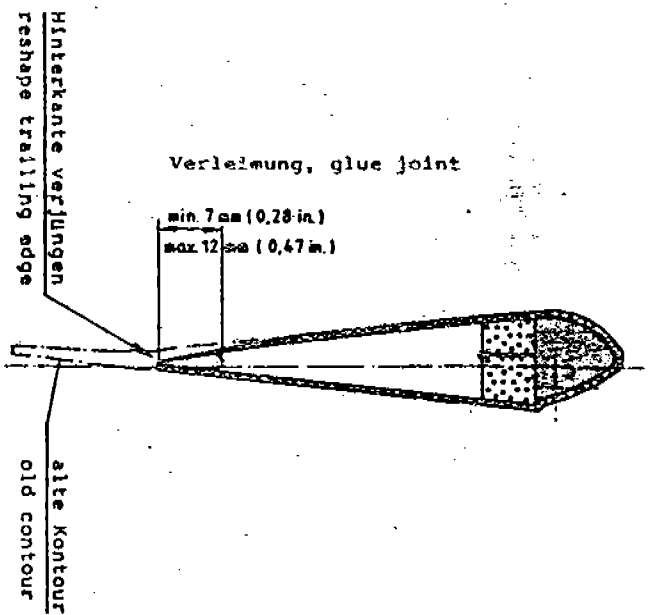
Sheet 4 No. of sheets: 4	ASV 19 Technical Note No. 17	Alexander Schleicher Segelflugzeugbau 6416 Poppenshausen
-----------------------------	------------------------------------	--

Sheet 2 No. of sheets: 4	ASW 19 Technical Note No. 17	Alexander Schleicher Segelflugzeugbau 6516 Pöppelhausen
<p>2. According to the sketch on sheet 4 of this TM, the elevator trailing edge is cut or ground off and reshaped on the lower surface.</p> <p>If you find when doing this job that the trailing edge glue joint between upper and lower surface of the elevator is no more sufficient, both surfaces have to be sanded and re-glued with the following glue mixture:</p> <ul style="list-style-type: none"> - 100 parts in weight of Epikote 162 - 38 parts in weight of Epikure 113 (= Laro-min 260) - and the following filler mixture: <ul style="list-style-type: none"> - 10 parts Aerosil - 5 parts cotton flocks Fl 17 - 15 parts microballoons, white. <p>The glue joint must be at least 7 mm wide, but no more than 12 mm.</p> <p>The width of the glue joint can be checked by means of a strong light in a dark room as well as by testing it by knocking with a metal piece of about 50 g (e.g. bolt M 8, ~ 80 mm long) on the trailing edge.</p> <p>The mass reduction by trimming and reshaping the trailing edge has the same effect as a much heavier mass balance in front of the elevator hinge line. Therefore, it is important to remove as much weight as possible from the trailing edge and to reduce a necessary glue joint to a minimum.</p> <p>For the same reason the reshaped lower surface should be smoothed by using only a minimum of filler. For preserving use white paint (original Lesonal 03-69469 with 10 x of hardener) or acrylic paint out of a spray can. Also here it is important to use as little material as possible.</p> <p>After the modification of the trailing edge has been accomplished, the airspeed indicator marking at 200 km/h (108 kts) must be removed and so also the speed limit has to be cancelled.</p> <p><u>Material:</u> Glue mixture and paint: see above chapter "Action 2."</p>

Modify the tailplane shape in accordance with Technical Note 17.
