THE GLIDING FEDERATION OF AUSTRALIA

GFA/AD 288

## AIRWORTHINESS DIRECTIVE

Centrair 101, 101A, 101AP, 101P

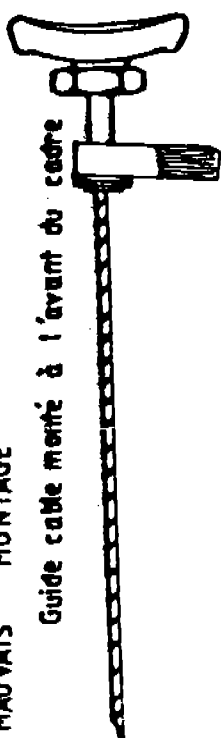
FIGURE 1

1 - Check whether the cable guiding fittings are mounted in front of the bulkhead (fig.1) or rear of it (fig.2)

MAUVAIS MONTAGE

Guide cable monté à l'avant du cadre

2 - If the fittings are mounted in front of the bulkhead, they must be remounted to the rear.

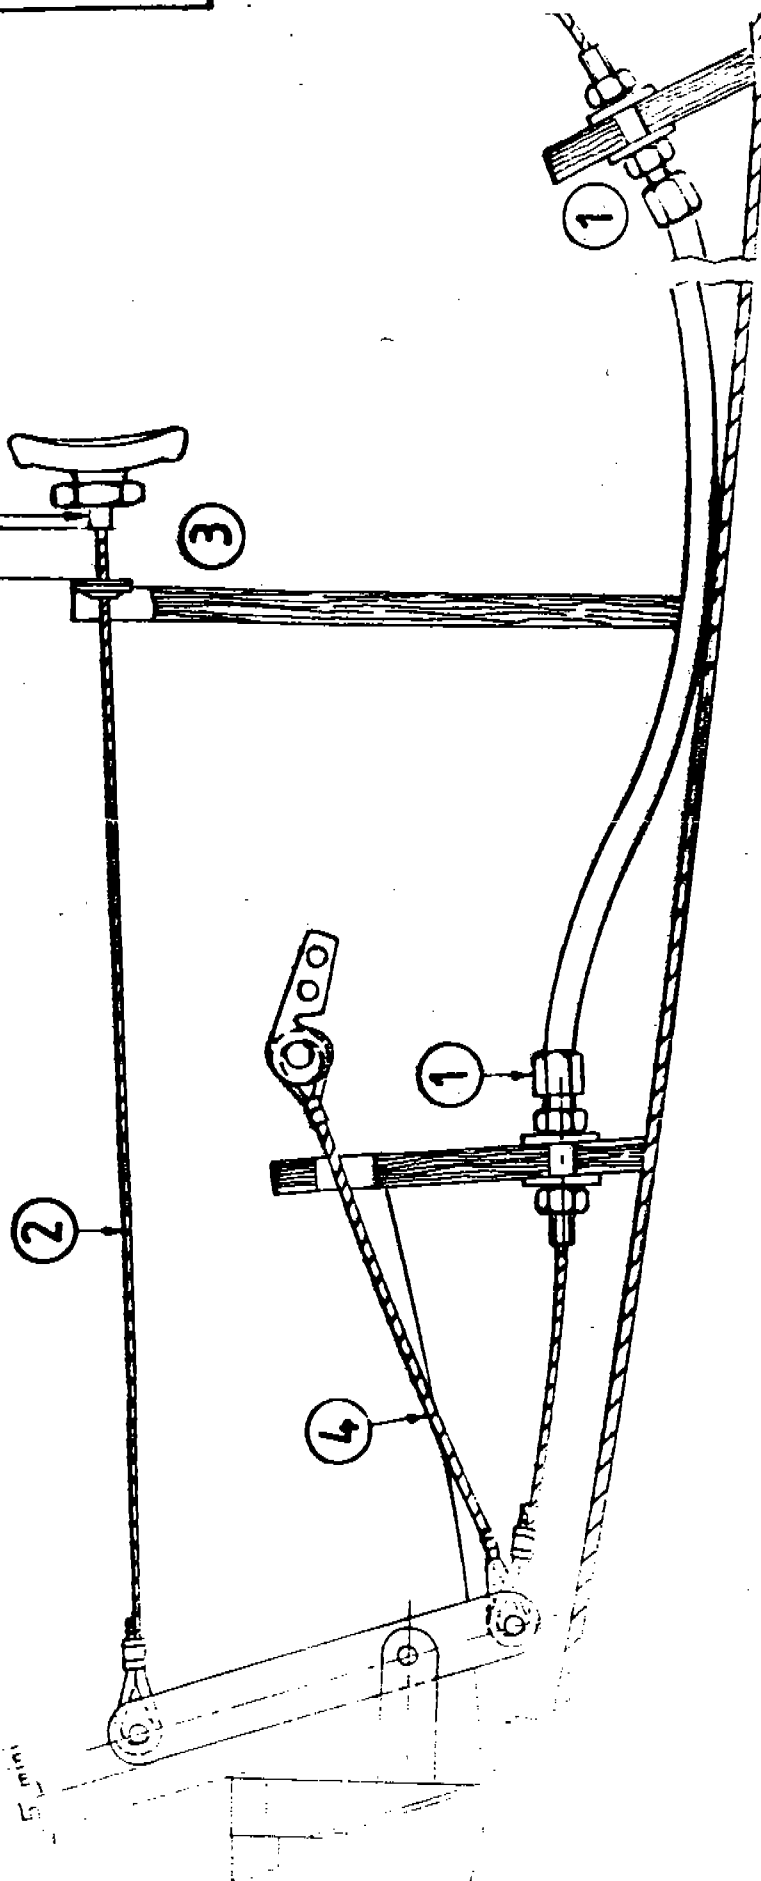
FIGURE 2

3 - Check whether sufficient neutral travel is left as indicated in figure 2.

MONTAGE CORRECT

Guide cable monté à l'arrière du cadre

JEU B 12

JEU A 5 mm

3.1. If backlash not sufficient in A :

3.11) On gliders with a rear hook only, screw the adjusted bits (rep. 1 fig.2).

3.12) On gliders with a front hook only, replace the cable (rep.4 fig.2)

3.13) On gliders with front and rear hooks, replace the cable (rep.4 fig.2) if this one shortens the neutral travel and play on the adjusted bits so that the stress is identical on the 2 hooks so that they release together.

3.2. After these operations, if backflash not sufficient enough in B :

3.21) On the gliders with rear hook only and with a plastic tube between the release cable fitting and the cable guide (rep. 3 fig. 2) to adjust it, shorten the plastic tube and/or screw the adjusted bits (rep. 1 fig. 2).

If no tube (rep. 3 fig. 2), screw the adjusted bits rep. 1 fig. 2.

If no back lash, replace the cable control (rep. 2 fig. 2)

3.22) On gliders with front and rear hooks or front hook only, and with the plastic tube, shorten the tube. If the tube (rep.3 fig. 2) doesn't exist or if no back lash, replace the cable control (rep. 2 fig. 2)
