AIRWORTHINESS DIRECTIVE

Powered sailplanes fitted with Rotax 505 engines
Serial No. 3332.580 to 3332.689

Inspection/replacement of cylinder holding down studs.

No. 505-01

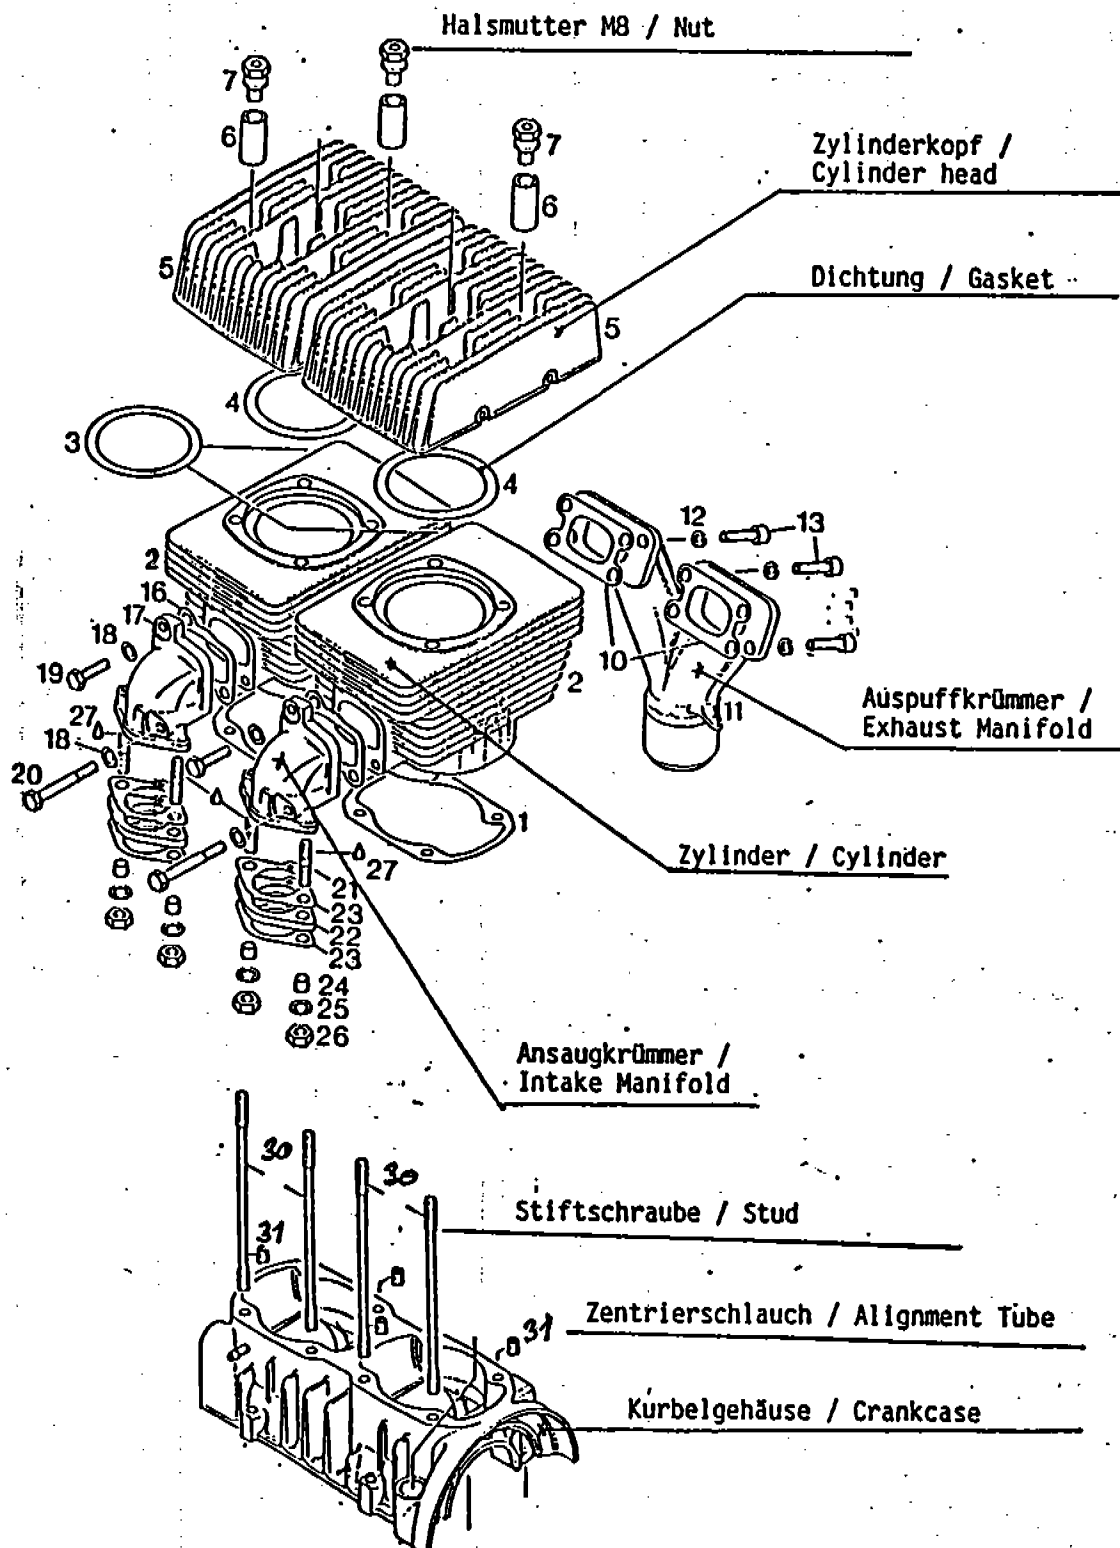
Blatt 3 von 3

Subject : Studs 840 585 (M8 x 177) connecting cylinders to crankcase (8x).

Reason : Breakage of studs.

TECHNICAL NOTE No. 505-01	Page 2 of 3
<p><u>Instruction for exchange of the 8 studs connecting cylinders to crankcase</u></p>		
<ol style="list-style-type: none"> 1) Remove socketnuts item 7 (see illustr. on page 3) diagonally and remove spacers (item 6). 2) Take off cylinder head, keep cylinders in position. 3) Remove cylinder head gaskets and if present, compression shims. Don't reuse gaskets, always exchange for new ones. 4) Carefully remove carbon deposits from top of piston and combustion chamber. 5) Exchange studs (item 30) diagonally across. <p><u>Attention:</u> Insert alignment tubes (2 per cylinder, positioned diagonally). Fit studs with shorter threaded end right to bottom of tapped blind hole.</p> 6) Refit cylinder heads, using new gaskets. <p><u>Attention:</u> Fit nuts and compensating washers in same position as prior to disassembly.</p> <p>Tighten socketnuts diagonally with 20 Nm.</p> 7) In case of stud breakage remove any remaining parts from the tapped hole in the crankcase.
