AIRWORTHINESS DIRECTIVE

TYPE AFFECTED: LS 4 and LS 4a up to serial number 4340

SUBJECT: Inspection and modification of the dive brake control circuit.

No. 4020

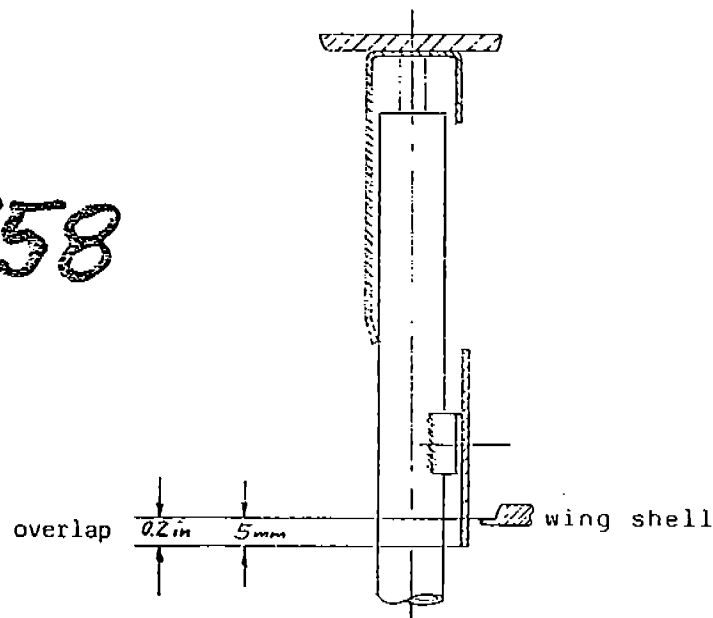
Reason: Possible jamming of lower air brake blade at high speeds

- 1) Assemble sailplane
- 2) With air brakes fully extended, measure overlap between lower blade and wing shell central to levers. When overlap is below 5 mm (0.2 in) proceed according to step 3.
- 3)a. Retract air brakes until overlap is at least 5 mm (0.2 in) at both wings
- b. Check extending height at inner lever, minimum is 150 mm (5.91 in). If below minimum, contact manufacturer.
- c. Rivet stop to air brake pushrod in cockpit from approx. 45° below horizontal such, that main bulkhead reduces travel to yield required overlap

Material: Stop 4R6-15, Steel blind rivet 4x10, (drill dia. 4.1 mm, DN 20)
