## AIRWORTHINESS DIRECTIVE

**TYPE AFFECTED:** SCHLEICHER ASK 21  
Serial Nos. 21001 to 21312 (Incl).

**SUBJECT:** INSPECTION/REPLACEMENT OF RUDDER PEDAL SUPPORT BRACKET

Subject: Inspection and exchange of the rudder pedal support fitting.

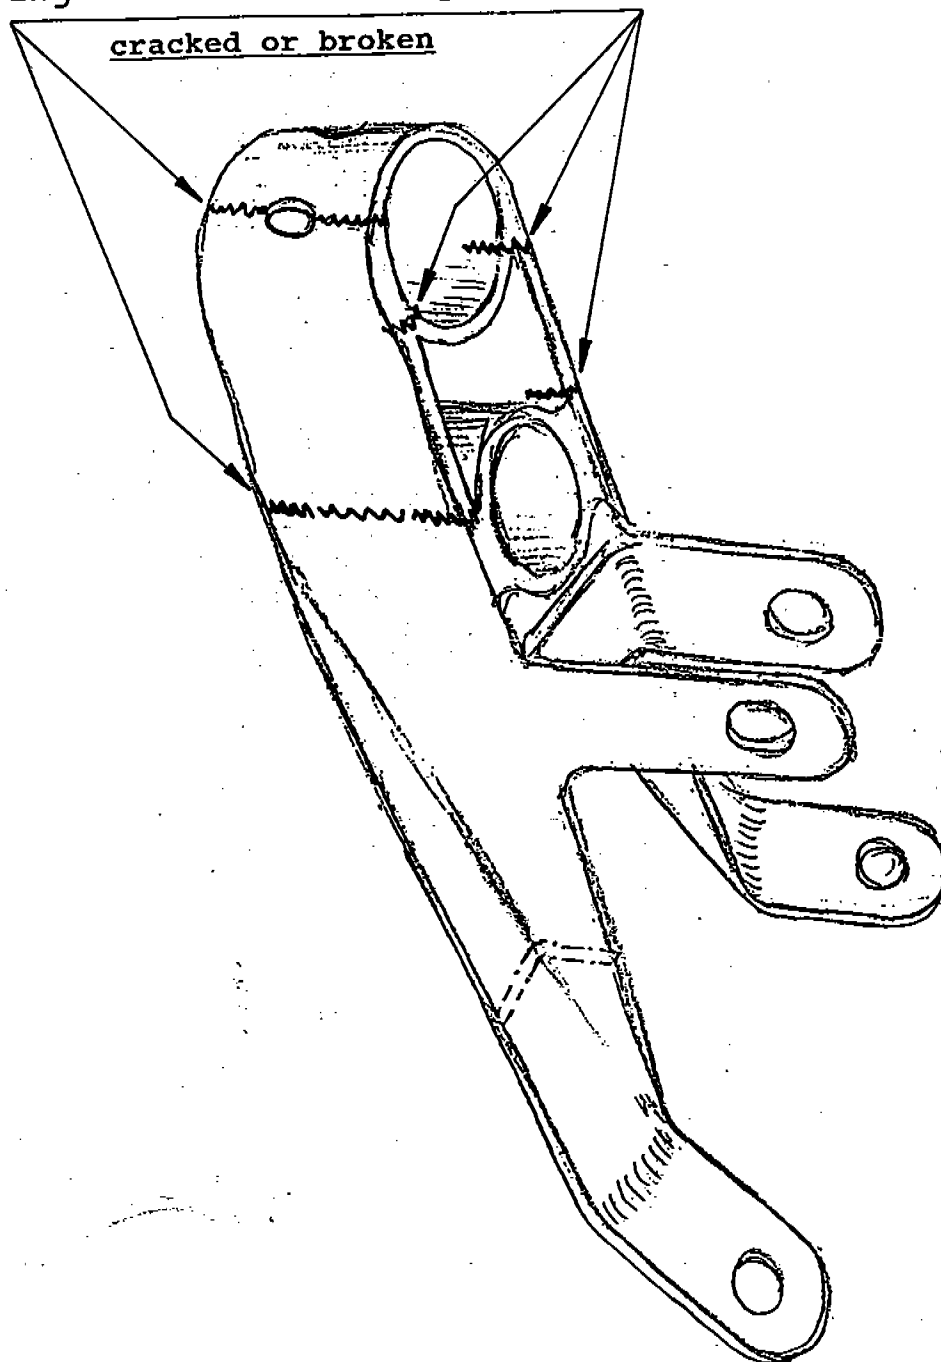
Fig. 1

Reason: On three ASK 21s which each have flown more than 1300 hours and more than 6000 take-offs respectively, this support fitting showed cracks or was broken (see Fig.1).

cracked or broken

1. Check the rudder pedal support fitting prior to the next take-off.
2. If cracks are found in this fitting, it must be immediately exchanged for a new one. If cracks are not yet visible, the support fitting must be exchanged in any case by April 1, 1987.

1. Order a new support fitting from the manufacturer; P/N 99.000.2174.
2. Remove the old support fitting; for this purpose the ø4 mm blind rivets must be drilled off.
3. Measure the position of the ø4 mm rivet holes on the removed fitting and transfer them accordingly onto the new fitting.
4. Install the new fitting and fix the upper pedal guide tube to the fitting using ø5 mm blind rivets.
