AIRWORTHINESS DIRECTIVE

Schempp-Hirth Cirrus
Cirrus VTC

Inspection of the divebrake control system.

GFA AD 317	Issue 1
3/9/1987	Sheet 2 of 3

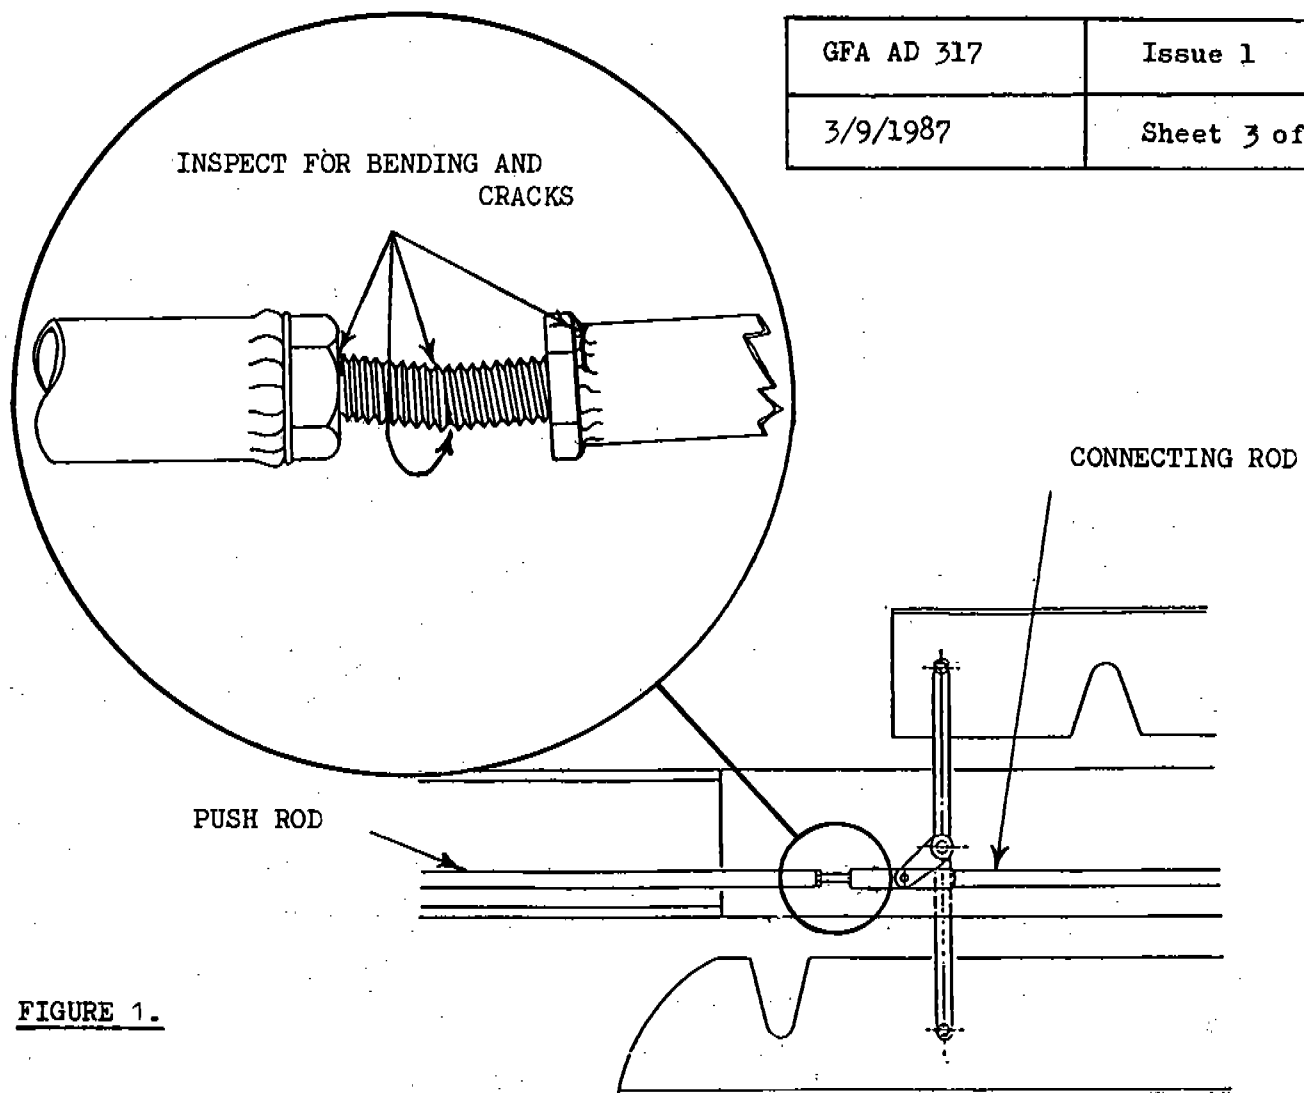
FIGURE 1.

On several Cirrus sailplanes overseas the bolt welded to the connecting rod for the divebrake arms (Fig. 1) has given trouble. (Schempp-Hirth Technical Note 265.8).

1. Remove the divebrake arm connecting rods from both wings and inspect them for defects.
 - (a) If the bolt is bent or cracked the connecting rod must be replaced with a new one or be repaired by cutting off the old bolt at the weld and welding on a new 8mm bolt. (Fig. 2).
 - (b) If the weld only is cracked and the bolt shows no other defects it may be repaired by re-welding.
 - (c) If the connecting rod has a 6mm bolt (Serials Nos 1 to 50 and it shows any of the above defects it must be replaced with a new connecting rod or the bolt cut off and new 8mm bolt welded on. The push rod will need to be drilled and tapped to suit.

NOTE: A BENT BOLT MUST NOT BE STRAIGHTENED.
