AIRWORTHINESS DIRECTIVE

TYPE AFFECTED: RF5B, RF5, and RF4 powered sailplanes

SUBJECT: Aluminium alloy aileron push rod corrosion and cracking

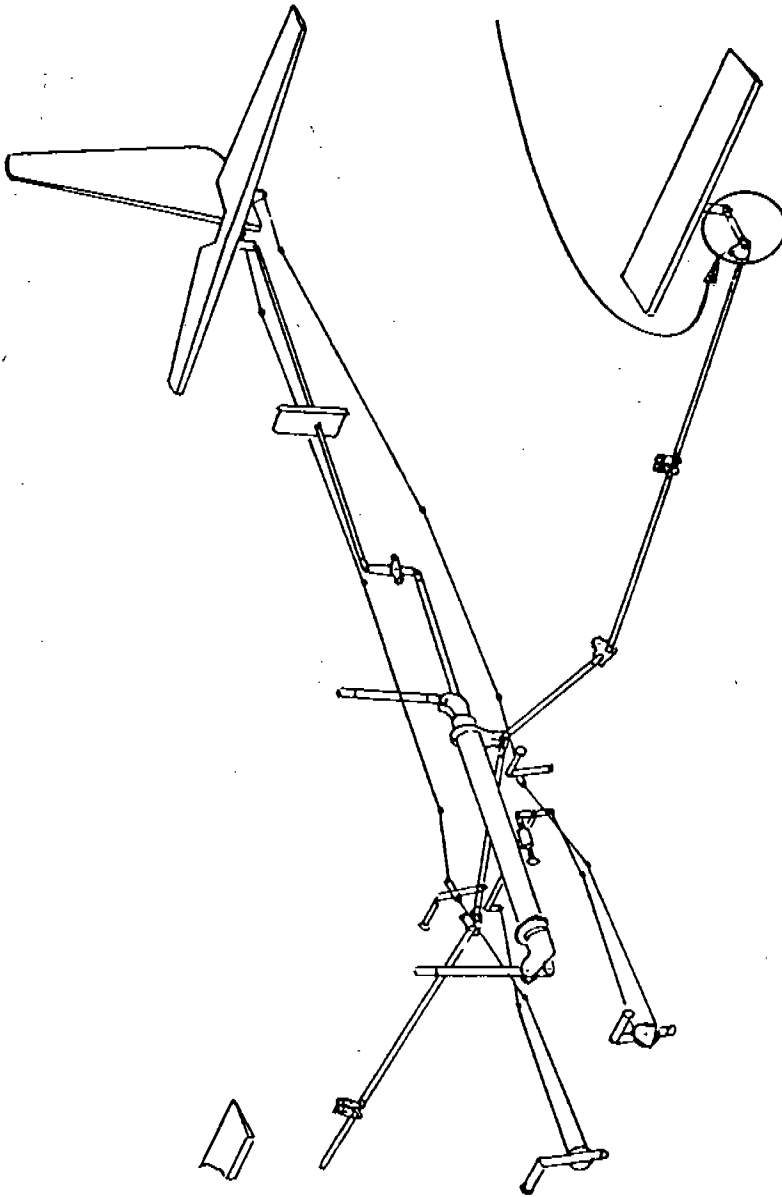
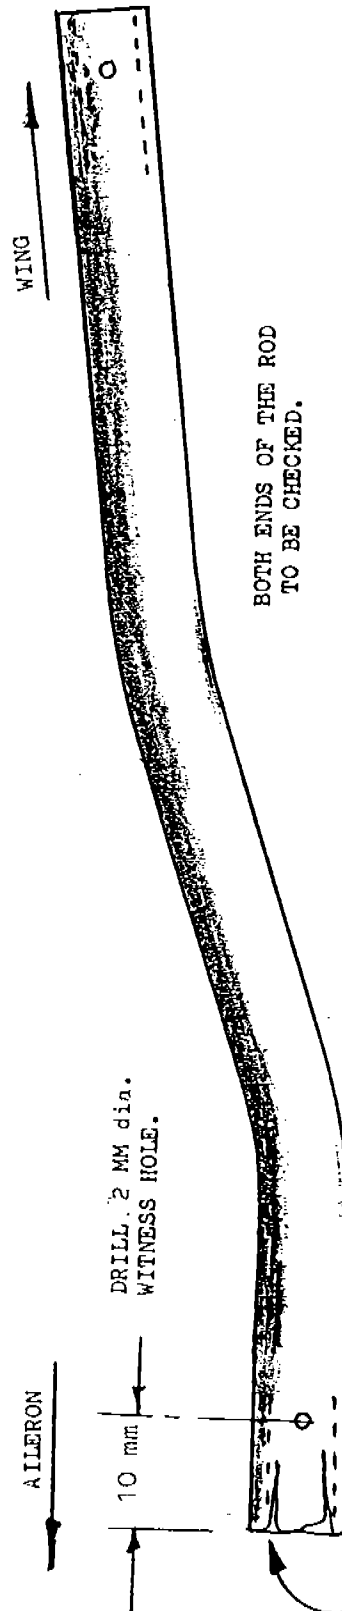
BACKGROUND: During a Form 2 inspection one end of an aileron pushrod (see illustration) was found to be corroded and badly cracked. It was lacking a "witness" hole at the corroded end.

REMOVE AND INSPECT THIS
PUSHROD , BOTH WINGS.

- 1. Before next flight**
Remove and check alloy pushrods for internal and external corrosion, cracking and witness holes. If corrosion and/or cracking are found, replace the rod. A new rod may be manufactured from 4130 steel rod or tube, formed, drilled and tapped to match the original rod.
Where a witness hole is lacking, drill a hole as illustrated. Internal application of a corrosion inhibiting fluid is strongly recommended.
- 2. At annual inspection**
Check pushrods for corrosion and cracking.
