## AIRWORTHINESS DIRECTIVE

LS 1 - All series  
LS 3 - All series  
LS 4 - All series

Loss of attachment between the 4 wing root rib pins and the wing root ribs. (Inspection/rectification)  
Inspection for wing root rib pin wear.

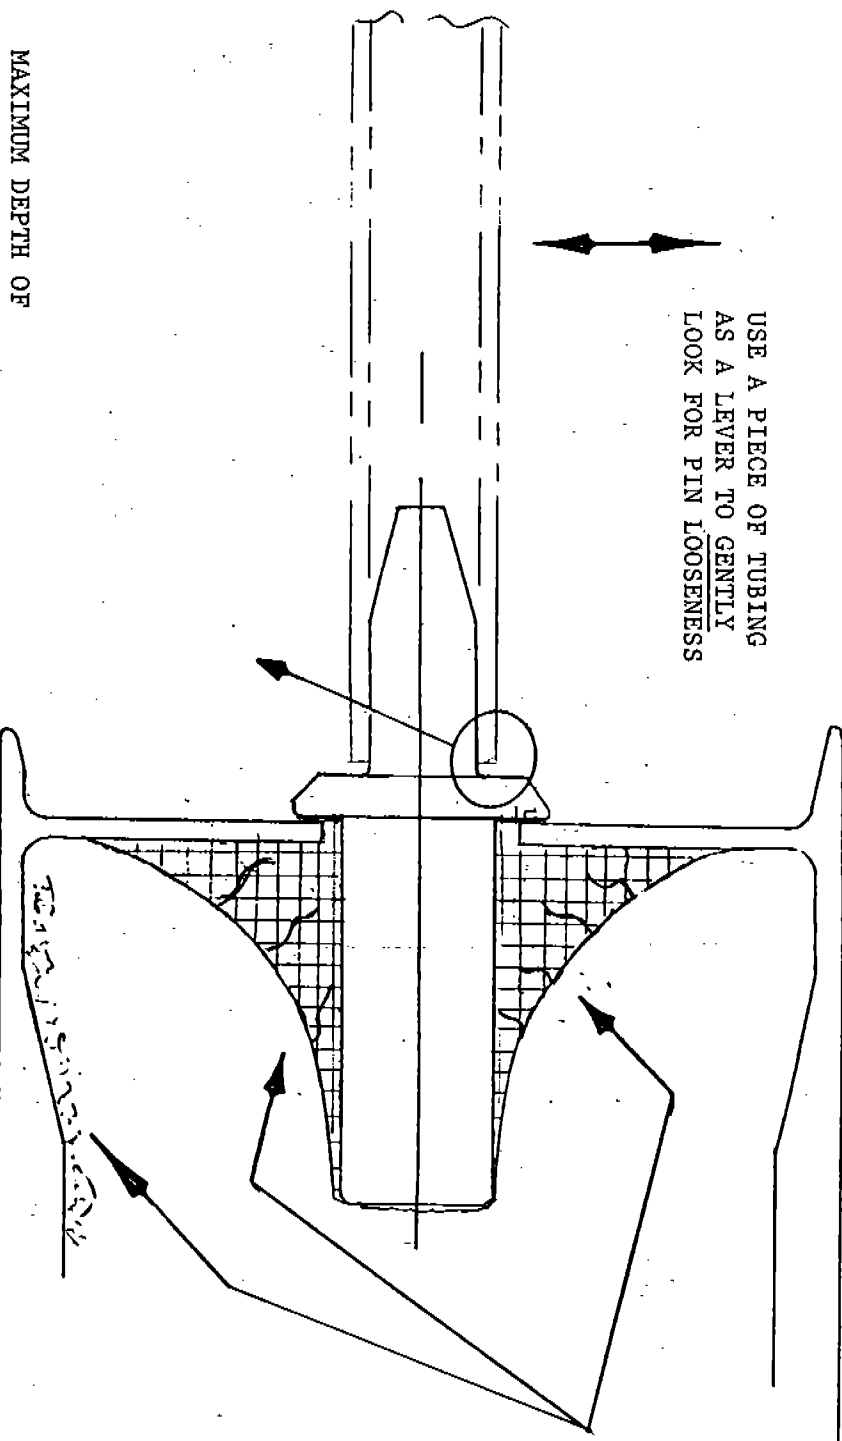
FIG. 1.

One case of an Australian LSI found to have cracking and loosening of the attaching material between the wing root ribs and the 4 wing to fuselage pins.

Factors causing the pin/rib attachment breakdown are not clear, but wing looseness due to pin wear combined with rough airfield surfaces, unsprung wing walking wheels, etc are all contributory.

- (a) Use an inspection mirror, through existing wing root rib holes to check the back of the pin mounting area (see Figure 1). Check the pin for movement (watch the back of the pin with the mirror at the same time).

USE A PIECE OF TUBING  
AS A LEVER TO GENTLY  
LOOK FOR PIN LOOSENESS

INSPECT FOR CRACKS IN THE  
FILLING MATERIAL AND SIGNS  
OF WHITE DUST PRODUCED BY  
"FRETTING".

MAXIMUM DEPTH OF  
WEAR  
• 250mm

SECTION SHOWN IS LS1  
LS3 AND LS4 DIFFER IN DETAILS

If movement/cracking is found the glider must be taken out of service and the wing root pins removed and remounted in accordance with GFA Mod 88/2. The fuselage bearings are to be also inspected for any signs of damage or looseness.

When these limits are exceeded new pins, either factory supplied, or manufactured to GFA Mod 88/2 must be fitted.
