## AIRWORTHINESS DIRECTIVE

GROB G109B powered sailplanes

Inspection/replacement of centre elevator hinges

Grob have identified a similar problem on the G109B and issued TM 817-25 detailing inspection and replacement of the 2 centre elevator hinge segments located on the elevator surface. (TM 817-25 forms part of this AD).

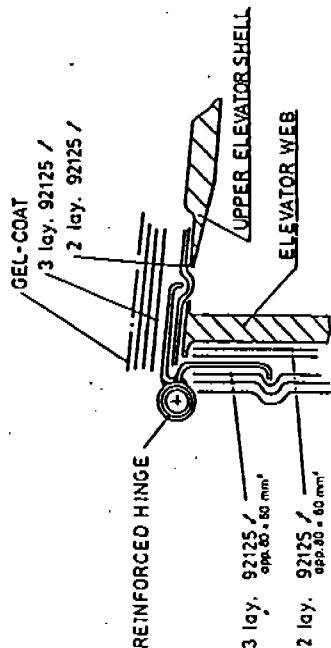
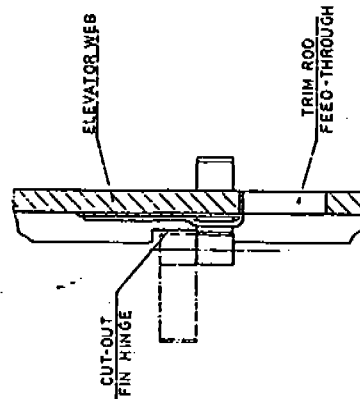
## ELEVATOR HINGE REPAIR

### SECTION OF COMPLETED REPAIR

EDGES ROUNDED WITH COTTON FLOCKS

### SECTION A - A

11. Fit in new hinges. It might be necessary to remove part of the web on the hinge seat in depth, so that the position of the opposite hinge is identical. The top of the hinge bracket must be approx. 1,5 - 2 mm underneath the outside contour of the elevator top (gel-coat).

12. Remove again both hinges.
13. Put two layers of glass-cloth 92.125 (80 x 60 mm<sup>2</sup>) on each of the ground areas of the elevator web.
14. Put two layers of glass-cloth 92.125 (size as required) on each of the ground areas of the elevator top.

15. Fit both hinges in and provisionally mount elevator on the fin.
16. Put immediately at least three layers of glass-cloth 92.125 (size and number of layers as required) on each hinge top side.

17. Allow to cure.
18. Remove elevator from fin.
19. Mill out trim feed-through.
20. Grind the glass-cloth on the elevator web (see 13.).
21. Put three layers of glass-cloth 92.125 (80 x 60 mm<sup>2</sup>) each on the hinge brackets on the elevator web.  
Note: On the side with the trim feed-through, put the three layers in the feed-through and glue them on the front side.

22. Allow to cure.
23. Neatly grind repaired spots. So as to ensure easy movement of the elevator, the laminate on the elevator hinges on the side of the fin might have to be slightly ground.
