## AIRWORTHINESS DIRECTIVE

**TYPE AFFECTED:** SZD-50-3 Puchacz

**SUBJECT:** Possible jamming of the rudder control system and modification of the trim tab connection.

BULLETIN No BR-43/50-3/92 "PUCHACZ"

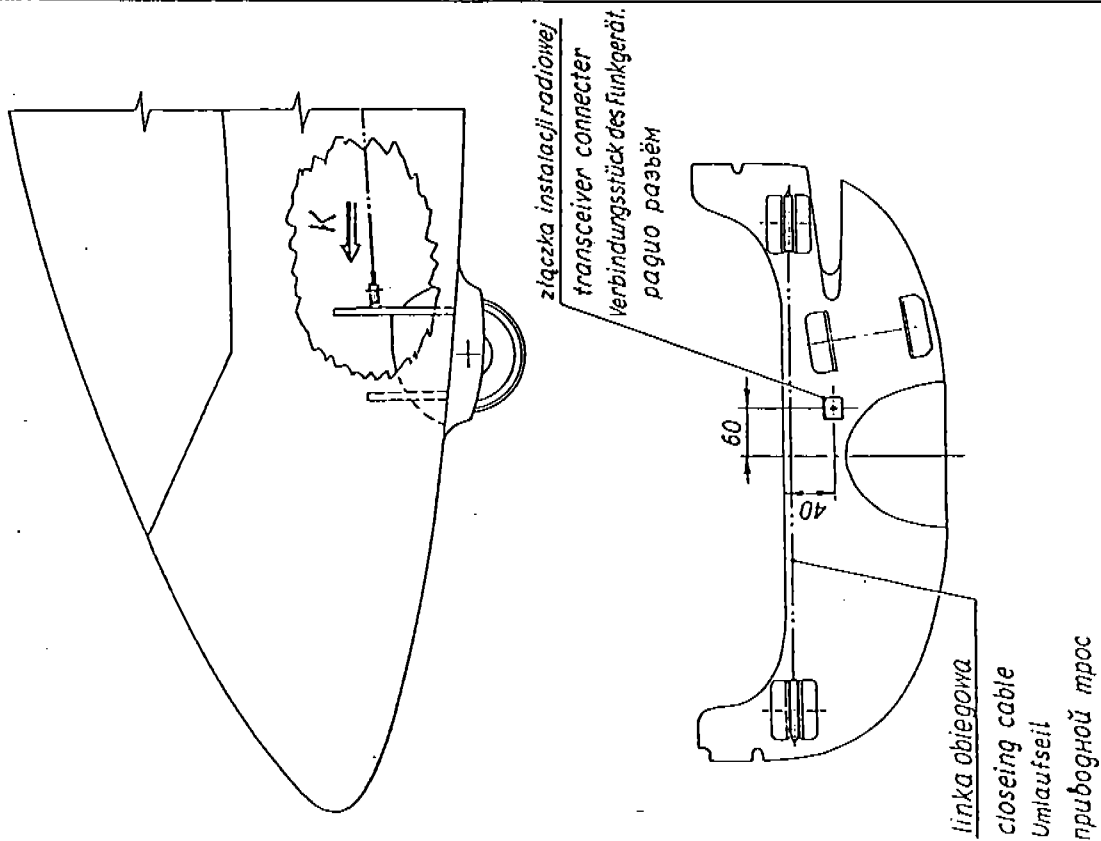
| <p>1. GROUNDS FOR INTRODUCING THIS BULLETIN.<br/>=====</p> <p>This Bulletin has been introduced to avoid the case of jamming of the closing cable of rudder control system onto the transceiver connector fixed on the frame set near the front seat.</p> <p>2. LIST OF GLIDERS COVERED WITH THIS BULLETIN.<br/>=====</p> <p>All SZD-50-3 "PUCHACZ" type gliders up to the Fact.<br/>No B-2052 incl.</p> <p>3. DESCRIPTION OF INTRODUCED CHANGES.<br/>=====</p> <p>3.1. It is recommended to check periodically the tension of closing cable in the rudder control system (the decreasing of the tension may cause the above mentioned cable jamming).</p> <p>3.2. It is proposed to move the transceiver connector acc. to sketch Fig. 1.</p> <p>4. LIST OF ENCLOSURES.<br/>=====</p> <p>No enclosures.</p> <p>5. WAY OF INTRODUCING THE CHANGES DESCRIBED IN THIS BULLETIN.<br/>=====</p> <p>5.1. By way of periodic inspection (e.g. after 50 flying hours) check the closing cable tension.<br/>In case the cable slackens adjust it acc. to item 2.2.6 of Technical Service Manual.</p> <p>5.2. Move the transceiver connector on the frame set near the front seat acc. to the dimensions given on the sketch Fig. 1.</p> <p>6. FINAL STATEMENTS.<br/>=====</p> <p>The introduction of the recommendations of this Bulletin should be recorded in the Glider Log Book, Chapter: Service Works.</p> | | |

| <p>BULLETIN No BE-42/50-3/92 "PUCHACZ"</p> <p>Ref: Elimination of the possibility that the closing cable of rudder control system can jam onto the transceiver connector fixed on the frame set near the front seat.</p> <p>Way of introducing: When this Bulletin is obtained.</p> <p>Elaborated in: PDPS-TKE.</p> <p>Director of "PZL-BIELSKO"</p> <p>Dipl. Ing. Jerzy SMUTKIEWICZ</p> <p>This is the translation of the original Polish text approved by the Airworthiness Authority.</p> <p>Translated by<br/>W. Stafiej, D.Sc.</p> | | |

złączka instalacji radiowej  
transceiver connector  
Verbindungsstück des Funkgerät.  
пригопақазбем

| <u>linka obiegowa</u> | closeing cable | Umlaufseil | приводной трос |

1. Before next flight and at each annual inspection the tension of the rudder closing cable must be checked in accordance with section 2.2.6 of the Puchacz Technical Service Manual.
2. At the next annual inspection but before 31 July, 1993 the radio connector must be relocated in accordance with section 5.2 and figure 1 of Technical Bulletin BE-42/50-3/92.
3. At the next annual inspection but before 31 July, 1993 the trim system washer at the tailplane must be exchanged in accordance with Technical Bulletin BR-43/50-3/92.

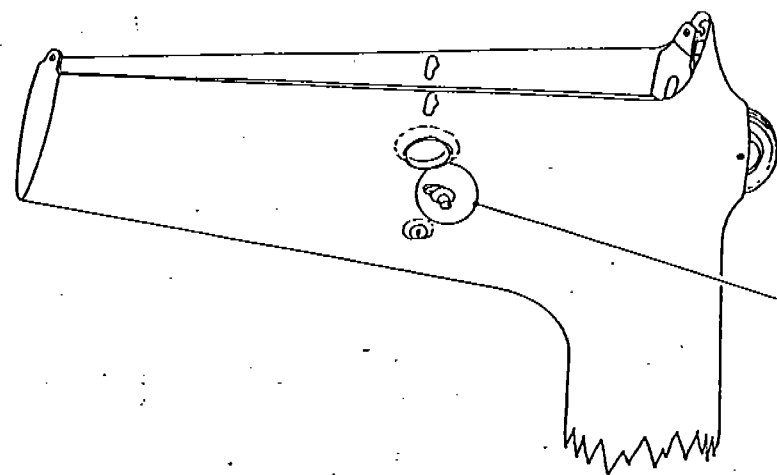
Fig. 1.

To avoid the cases of "sinking" the trimming-tab control system torque tube (503.63.30.00) into the oval opening in the fin covering (what can happen when assembling the tailplane) this Bulletin introduces the change of the diameter of centering washer what eliminates the above described fault.

The Bulletin concerns only those SZD-50-3 "PUCHACZ" gliders on which it was found that the washer securing the "central" position when the torque tube is displaced laterally "sinks" into the oval opening in the fin covering (see sketch Fig. 1).

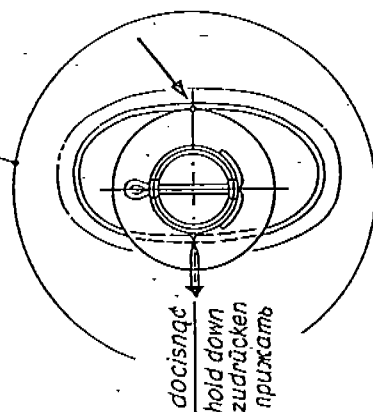
Podkładka  
(503.63.39.00)

washer

mat. 20-N (1x36x36) - cynkować  
2 szt./kol.

In the necessary cases the special washers ensuring the centralization of the torque tube in respect to the fin should be replaced with the "new" ones having the outer diameter of  $\phi 36$  (Drawing 503.63.39.00) - see Fig. 2.

5.1. Having the tailplane disassembled - remove the safety pin  $\phi 2,5$  securing the washer against falling down, then remove the washer. Repeat the same on the opposite side.

5.2. Replace the "new" washers ( $\phi 36$ ) and secure with the safety pins.
