**GFA AD 409**  
(ISSUE 1)

### GFA AIRWORTHINESS DIRECTIVE

**TYPE AFFECTED:** Dimona H36 up to serial number 36268.

**SUBJECT:** Inspection and possible replacement of the main pins.

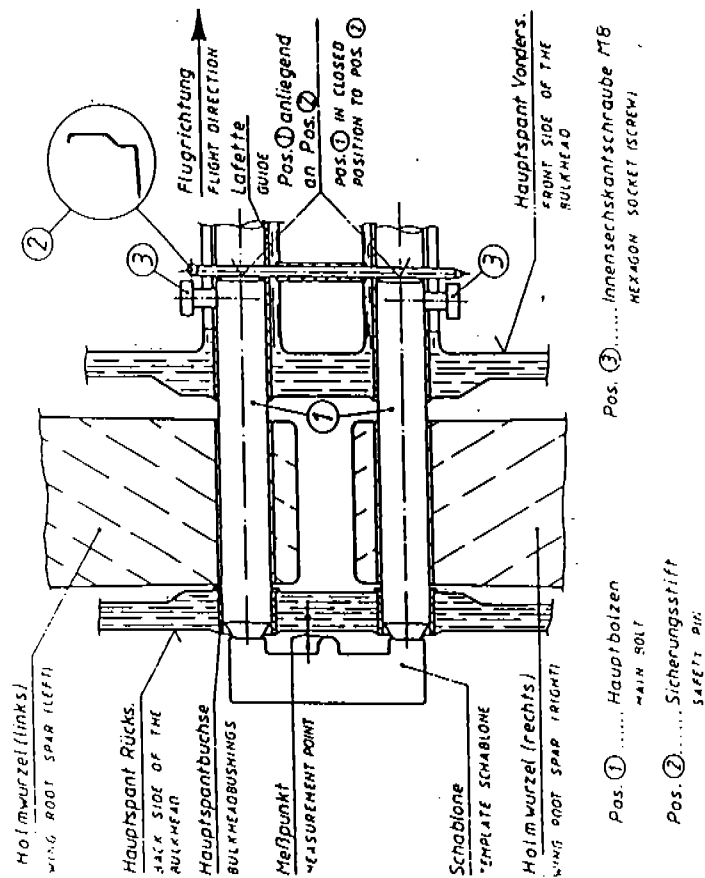
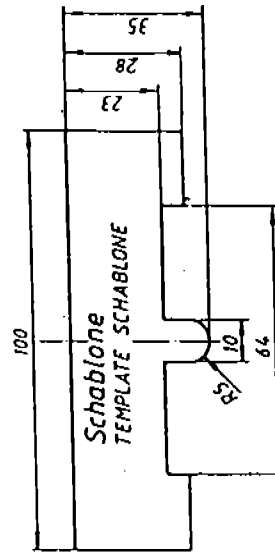
Skizze 1  
SKETCH

1. Push the main bolt in flight direction up to the wing safety pin  
using wing assembling lever.
2. Measure the distances between the main bolt heads and the back side  
of main bulkhead using the enclosed template and torch light in  
accordance with sketch 1:

3. If the measurement point of template doesn't touch the main bulkhead:  
no further actions necessary.
4. In case measurement point of template touches the main bulkhead  
(excluded bad surface furnishings) performe the following actions  
using the main bolts which will be delivered by the manufacturer:

- 4.1 Wing disassembling in accordance with airplane flight manual
  - 4.2 Remove the fuel tank
  - 4.3 Remove the main bolt hexagon socket screws (pos. 3) secured by  
Loctite cement.

- 4.4 Remove both main bolts against the flight direction. If necessary  
remove slightly the spoiler rod before.
  - 4.5 Compare the diamaters of new with the old main bolts. Tolerance:  $\pm 0,0 \text{ mm}$   
 $- 0,04 \text{ mm}$

- 4.8 Installe the main bolts into the previous position.
  - 4.9 Installe the hexagon sockets into the main bolts using Loctite 648  
cement for security (using standard torq 16 Nm).
