## GFA AIRWORTHINESS DIRECTIVE

**TYPE AFFECTED:** Cirrus and Cirrus VTC

**SUBJECT:** Fatigue life limits on the L'Hotellier coupling balls in the air brake circuit.

| GFA AD 414 | ISSUE: 1 | 18 April, 1994 | Page 2 of 2 |

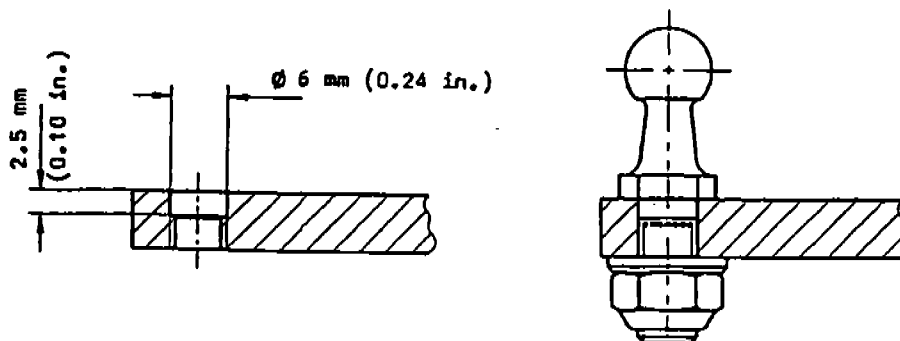
FIGURE 1

**BACKGROUND:** Overseas experience has shown that it is necessary to replace the air brake L'Hotellier coupling balls more frequently than was previously thought.

The replacement ball design has been modified by the manufacturer. The thread length is now slightly shorter and begins 2.5 mm below the flange and it is necessary to relieve the belcrank hole to allow the flange to sit flat on the belcrank surface.

2. At the first installation of the coupling ball with the new part number drill a recess 2.5 mm (0.1 in) deep and 6.0 mm (0.24 in) diameter into the side of the belcrank facing the coupling ball (drill bit included angle  $\geq 115^\circ$ ) enabling the ball to tighten against the belcrank. See figure 1.
