## THE GLIDING FEDERATION OF AUSTRALIA

# AD 417

### AIRWORTHINESS DIRECTIVE

Subject: Cracks at the frame of the TOP-engine pod

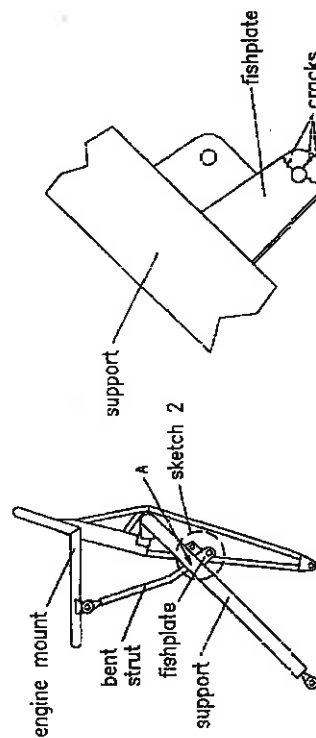
Sketch 1 engine mount-frame

Some fishplates at the support of the TOP-engine pod showed cracks, which could cause the failure of these fishplates. In this case engine and propeller would not be guided correctly.

Sketch 2 position of the cracks

The fishplate at the support (A-shaped part of the frame) must not show any cracks. For inspection clean the fishplates with a dry rag and look for cracks (see sketches 1 and 2). Cracks have to be repaired according to Action 3. If there are not any, only Action 2 is necessary.

The bent struts must not be pressed against the support at position A (see sketch 1). The rod ends of the bent strut make it possible to turn the strut slightly, while the distance between support and strut changes. When the strut is turned away distance must be at least 0,3 mm. The lower fixing screws of the bent struts have to be 22 mm long (M6x22).

The cracks have to be TIG-welded by a licenced TIG-welder. The material of the fishplate is 1.7734.4. A welding certificate is necessary. The areas, where the fishplate is in contact with the brass collars or the screw heads, have to be filed plane. Areas with damaged surface protection must be primed and painted with fuel resistant varnish. The mounting of the repaired support takes place in the reverse order of removing it. Hereat the bent strut must be mounted as described in Action 2. The distance 0,3 mm has to be checked.
