GFA AD 426

GFA AIRWORTHINESS DIRECTIVE

L13 Blanik and L13 A1 Blanik All serial numbers.

Cracking of wing Ribs.

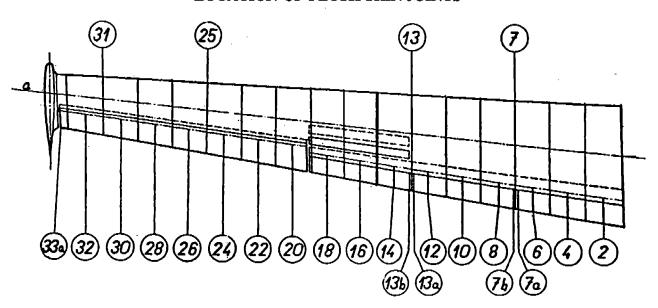
FIGURE 1 LOCATION OF FLUSH SKIN JOINTS

During a routine inspection cracking was noted in the flange of the wing rib and the stiffeners at the flush skin joint at station 13.

Further inspection of other Blaniks showed that 7 out of 9 inspected gliders had cracking of some degree at this station. Inspection of the ribs at other stations with flush skin joints also showed minor cracking at station 7.

The Flush Joints at Stations 25 and 31 are the same detail design as stations 7 and 13 and so are possible cracking sites.

The extent of the cracking was such that the worst wing was very near to failure.

The top and bottom flanges of the rib and the stringers at Station 13 must be inspected for cracks.

The wing must be inspected at stations 7, 25 and 31 for cracks in the wing rib flanges and the stringers.

Depending on the degree of damage found the glider will need to be repaired in accordance with the following schedule.

No stiffener cracked more than 12 mm. No rib flange cracks.	Inspect every 50 hours.
Any stiffener cracked in excess of 12 mm. No rib flange cracks	Inspect every 50 hours. Repair within 100 hours.
Any stiffener cracked in excess of 12 mm. Any rib flange cracks not more than 30 mm.	Repair within 50 hours.
No stiffener cracked more than 12 mm. Any rib flange cracks not more than 30 mm.	Inspect every 50 hours. Repair within 100 hours.
No stiffener cracked more than 12 mm. Any rib flange cracks more than 30 mm but less than 60 mm.	Repair within 50 hours.
Total damage found exceeding the above levels.	Repair before next flight.

A suggested repair scheme is available from Aviation and General Engineering as Engineering Order 9401 for which a kit of parts is also available.

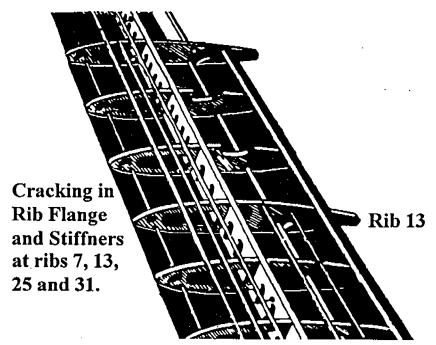
On both upper and lower surfaces the skin junction must be pressed in using finger pressure to ascertain relative movement. Cracking will show up as relative movement of the abutting skins and there will be noises with the movement as the fracture surfaces click past each other. (Note: even without cracking there may still be a small amount of relative movement.)

Cracking may also be detected by shining a torch at the junction and observing for light on the inside of the wing.
