THE GLIDING FEDERATION OF AUSTRALIA

GFA AD 431
(ISSUE 1)

GFA AIRWORTHINESS DIRECTIVE

Corrosion and cracking of the swaged pushrod ends.

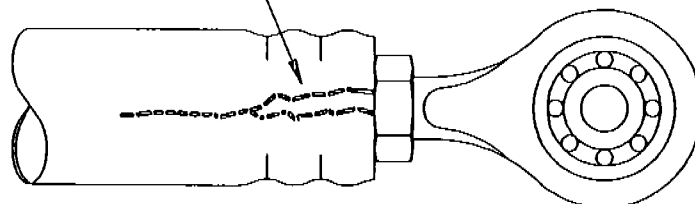
FIGURE 1

On a SZD-48-1 Jantar Standard 2 the swaged pushrod end split open under the pressure caused by exfoliation corrosion.

Corrosion of internal fitting causes splitting.

Note that the self aligning rod end shown is not the only type of fitting swaged into pushrods. Other types include the control quick connectors and the clevis fork.

1. Before next flight examine all swaged pushrod ends for signs of corrosion and splitting. (see figure 1 for details.) Note: some of these swages are difficult to access and special care must be taken to ensure that all fittings are inspected. The use of a mirror is highly recommended.

2. The inspection must be repeated at each annual inspection
