## GFA AIRWORTHINESS DIRECTIVE

**SUBJECT:** Inspection and modification of the tailplane locking mechanism.

**DOCUMENTATION:** Schempp-Hirth combined technical note: 278-36, 286-33, 295-26, 328-11, 798-3

| <b>Schempp-Hirth</b><br><b>Flugzeugbau GmbH</b><br>Postfach 1443<br>D-73222 Kirchheim unter Teck<br>LBA-Nr. IB 5 | 278 - 36<br>286 - 33<br>295 - 26<br>328 - 11<br>798 - 3 | Page No. 1<br>No. of pages 2 | | | | | | | | | | | | | | | |
|---|---|---|---|---|---|---|---|---|---|---|---|---|---|---|---|--|--|
| <u>Subject</u> : Attachment of the horiz. tailplane | | | | | | | | | | | | | | | | | |

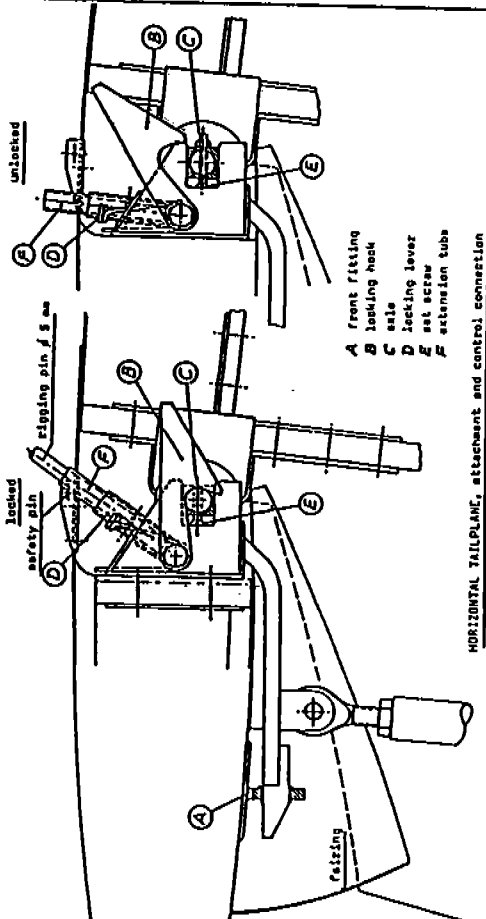
| <u>Reason</u> : Due to the lack of maintenance or because of wear, the locking hook on the tailplane attachment bracket became disengaged in a number of cases, so that the horizontal tailplane was no longer securely attached to the fin. | | |

| <u>Actions</u> :<br>1. Re-adjustment of the set screws on the tailplane attachment bracket to eliminate any tangential play. Follow the instructions given in the Service Manual, section "Backlash of the attachments".<br>Note! Should it prove impossible to eliminate the play in the tailplane suspension (move tips of tailplane back and forth), the tailplane attachment bracket with its locking hook (B) must be removed.<br>2. Installation of a safety device for the locking lever (D) in accordance with the working instructions given in the appendix.<br>3. Check of the rigged and secured horizontal tailplane for full and free movement up to the stops. | | |
