## GFA AIRWORTHINESS DIRECTIVE

**TYPE AFFECTED:** Grob G 109B. All serial numbers.

**SUBJECT:** Inspection of the engine mount for abraded areas.

**Subject:** Inspection of the engine mounting frame for abraded areas

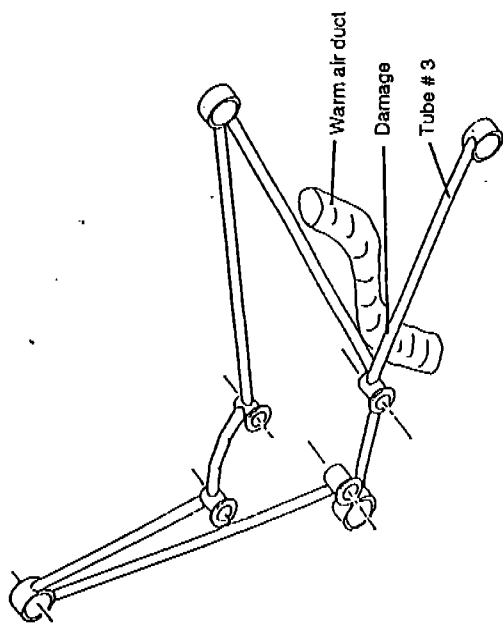
**BACKGROUND:** Notches have been found in the engine mounts of affected aircraft as a result of abrasion with the air duct running from the heat exchanger to the left hand carburettor.

**Procedure:** Some isolated cases have been reported to GROB of abraded areas on the engine mounting frame. The abrasion forms notches on tube # 3 of the engine mounting frame. These notches are parallel to the tube and are caused by the steel spiral of the warm air duct running from the heat exchanger to the LH carburetor rubbing on the mounting frame (see sketch).  
In the cases which have come to our notice, the abrasion has arisen on privately maintained aircraft on which an excessively long warm air duct was installed.

- Action:**
1. Inspect tube # 3 of the engine mounting frame for abrasion.
  2. If abrasion is not detected, no further action is necessary.
  3. If abrasion is detected, proceed as follows:

- (a) If the abrasion is of a minor nature (paint scratched off), remove any corrosion from the area and remove dust. Degrease the tube and apply a protective anti-corrosion coat. Shorten the warm air duct or replace it, if damaged.
- (b) If the abrasion is more severe (up to a depth of 0.7 mm), provisionally protect the engine mounting frame as described in para. 3. (a) and perform final repairs in accordance with para. 4 not later than 31.12.1995.
- (c) If the abrasion is deeper than 0.7 mm, repair the engine mounting frame immediately in accordance with para. 4.

Because the repair must be performed in a welding jig, the engine mounting frame can only be repaired by GROB. Return the degreased mounting frame to GROB together with the attached form.

**5. In addition, inspect all tubes of the engine mounting frame which may be subject to abrasion and protect where necessary with rubber tubes which have been cut open. Attach the rubber tubes to the mounting frame using Ty-raps.**
