GFA AD 445

GFA AIRWORTHINESS DIRECTIVE

LS 3, LS 3a, LS 3-17.

Air brake drive mechanism inspection and modification.

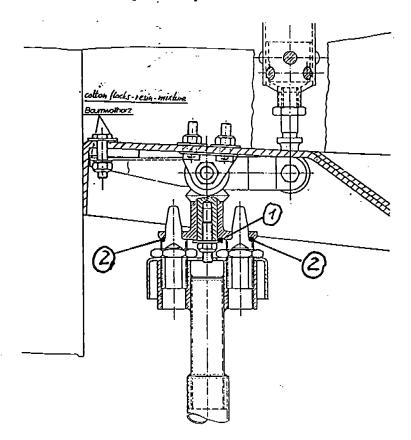
: With excessive play in bevel gear drive at root rib or at fuselage drive between root ribs, the retaining bolt of the gear drive plate may fail.

Compensation of play by shims 14*10 mm. (When this play is excessive, the root rib is being deformed during locking, resulting in possible failure of the bevel gear plate retaining bolt and also air brake being either not completely retractable or extendable).

Drawing of root rib and air brake drive, indicating regions for adjustment of play:

- Teller des Kegelradgetriebes bevel gear drive plate
- (2) rumpfseitige Antriebsbolzen fuselage drive pins

- : 1) Check play in bevel gear drive at root ribs:
 : The bevel gear drive plate must be axially free from play, but should be unbraced. Compensation of play by shims 16*12 mm (When this play is excessive, the plate may skip over one or more teeth, resulting in air brake being either not completely retractable or extendable).
 See also drawing on page 2.
 - After rigging the plane check spanwise play of fuselage air brake drive between bevel gears with air brakes not locked. Also, this value must be free from play, but unbraced.

3) Modification of the air brake bevel gear unit to version "a" (Drawing 1BF-4a), identifiable by locking nut M8, width over flats 13 mm at the gear drive plate, instead of locking nut M6, width over flats 10 mm.
