**GFA AD 446**  
(ISSUE 1)

**GFA AIRWORTHINESS DIRECTIVE**

**SUBJECT:** Correct Safety Locking of the landing gear drive.

| ROLLADEN-SCHNEIDER<br>Flugzeugbau GmbH<br>LBA-Nr. EB - 4 | Technical Bulletin<br><br>No. 3045 / 4036 | all LS3<br>LS4<br>LS4-a | Page 1/2 |

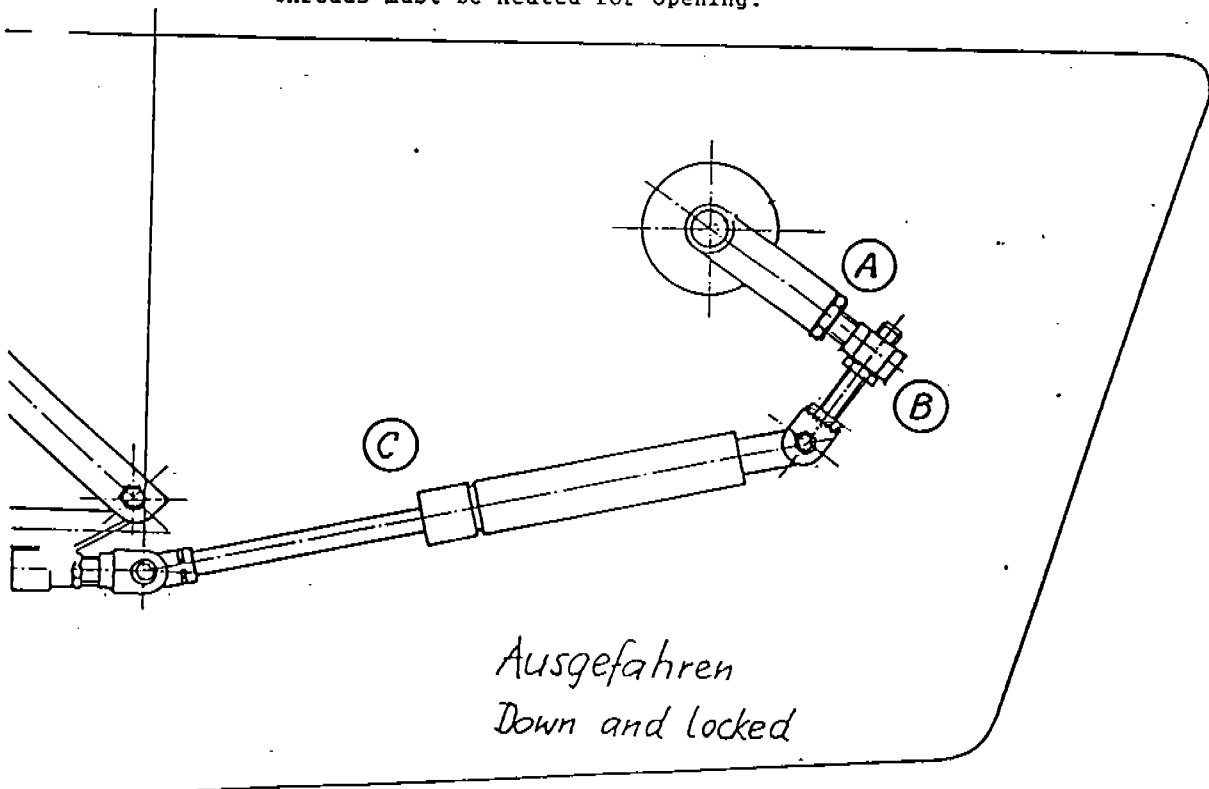
REASON : Landing gear locking failed due to improper locking of nuts.

Drawing of landing gear drive at the left side of the landing gear box, adjustments at A and B, accessible after removal of the baggage compartment cover. When fitting a new gas strut C the following must be checked: During locking the gas strut must be compressed by about 5 to 8 mm (0.2 to 0.3 in) to ensure total strut force acting as preset load for locking.

- <A> Stellschraube mit Mutter, Gewinde M10  
adjuster with nut, M10 thread
- <B> Stellschraube mit Gabel, Gewinde M8  
adjuster with fork, M8 thread

MATERIAL and : Check locking of nuts in the landing gear drive:  
INSTRUCTIONS : A) Thread M10, Width over flats 19 mm,  
torque 45 Nm (33 lb\*ft)  
B) Thread M8, width over flats 17 mm,  
torque 25 Nm (18 lb\*ft)  
Additional safety by applying thread securing fluid (for  
example: Loctite)

Additional safety by applying thread securing fluid (for example: Loctite). For later adjustments, these secured threads must be heated for opening.
