GFA AIRWORTHINESS DIRECTIVE

TYPE AFFECTED: DG-100 all series
DG-200 all series
DG-300
DG-400
DG-500 all series (including powered sailplanes)
DG-600 all series (including powered sailplanes)

SUBJECT: Failure of a cantilevered bellcrank pivot mount.

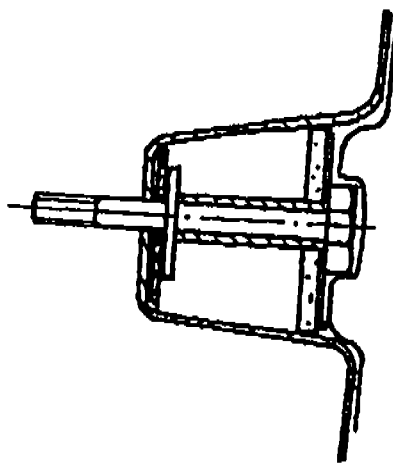
Figure 1. Typical pivot bracket

BACKGROUND: A case has been reported where the bellcrank pivot in the elevator drive circuit of a DG-200 failed causing the elevator circuit to jam. Fortunately this was detected in the pre-flight inspection.

The type of cantilever pivot support which failed is typical of the pivots used throughout DG gliders.

ACTION REQUIRED: Before next flight all pivot support brackets which are similar to the one shown in Figure 1 must be tested by applying a torque to the nut. The correct torque will depend on the size of the pivot bolt and is shown in Table 1. It is not known that sizes other than M6 and/or M8 are fitted however if bolt of other sizes are found then the CTOA should be contacted.

The torque must be applied using an accurate torque wrench.

The part will be considered to have failed the test if there is any movement of the bolt, any cracking sounds are heard or there are any other indications of failure.

Inspectors will need to ensure that all similar mounts within the glider have been checked even if a hole has to be cut in the structure to access the nut. Unless specific approval is granted all holes must be repaired once the test is completed.
