## GFA AIRWORTHINESS DIRECTIVE

**TYPE AFFECTED:** K 8, K 8B, K 8C. All models all serial numbers including kit or licence built gliders.

| <b>GFA AD 459</b> | <b>ISSUE: 1</b> | <b>21 October, 1996</b> | <b>Page 2 of 6</b> |

| SHEET:<br>2 of 4 | K 8<br>Technical Note<br>No. 24 | Alexander Schleicher<br>GmbH & Co.<br>Segelfluggelbau<br>XXIX-616 Poppenhausen |

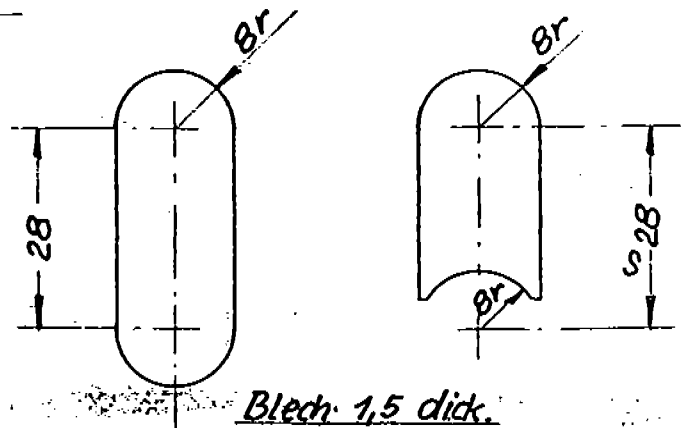
Fußsteuer L-216.42-401

- a) Use of an incorrect canopy retaining chord may prevent the canopy from jettisoning in an emergency.
- b) If overloaded the rudder pedals mounts may bend restricting rudder travel.
- c) An accident overseas may have been caused by a bend in an elevator pushrod from an earlier accident eventually failing.
- d) Corrosion may form in the steel tube framework.
- e) The maximum allowable play in the wing to fuselage attachments has been defined.

1. At each Annual Inspection ensure that the correct weak link in the canopy retaining chord is installed as per Action A1 in K 8 Technical Note No. 24.
2. At each Annual Inspection inspect the rudder pedals in accordance with Action A2 of K 8 Technical Note No. 24.
3. At each Annual Inspection inspect the elevator pushrods in accordance with Action A3 of K 8 Technical Note No. 24.
