**GFA AD 465**  
(ISSUE 1)

**GFA AIRWORTHINESS DIRECTIVE**

**TYPE AFFECTED:** SZD-42 Jantar 2  
SZD-42-1 Jantar 2  
SZD-42-2 Jantar 2B

**SUBJECT:** Inspection of the spar spigot pin at the outer wing panel junction.

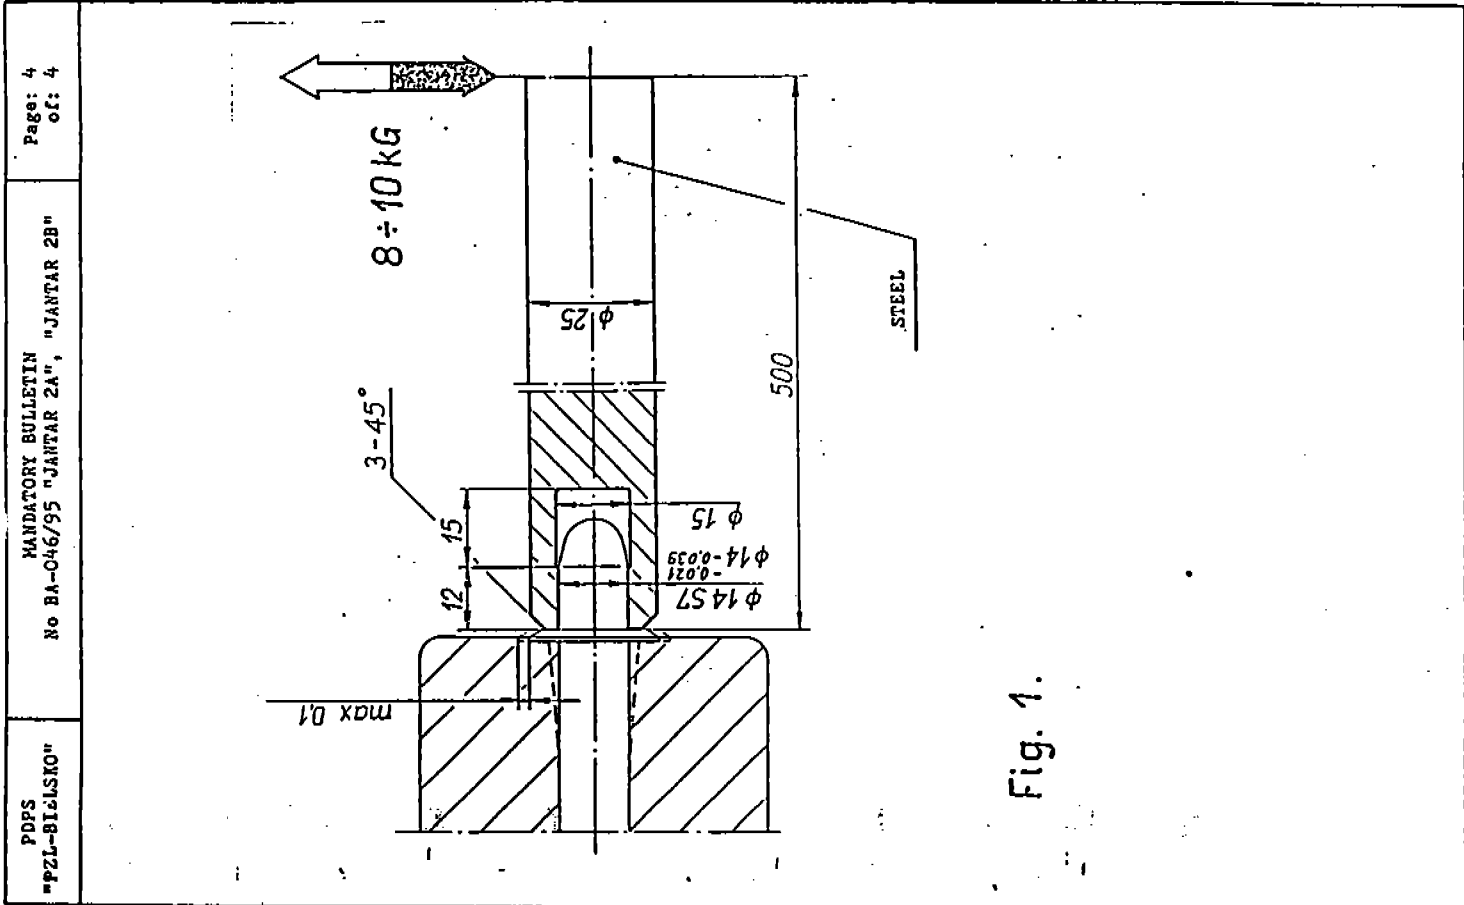
| PDPs<br>"PZL-BIELSKO" | MANDATORY BULLETIN<br>No BA-046/95 "JANTAR 2A", "JANTAR 2B" | Page: 2<br>of 4 |
|---|---|---|
| | <p><u>1. GROUNDS FOR INTRODUCING BULLETIN</u></p> <p>During the periodic inspections of gliders operated by Hungarian Aeroclub, on several planes a small radial clearance has been found on the pin installed in the spar end, at the detachable wing tip connection.</p> <p><u>2. LIST OF GLIDERS FACT. NO COVERED WITH THIS BULLETIN</u></p> <p>All gliders of SZD-42, SZD-42-1, SZD-42-2 type, with four panel wings are covered with this Bulletin.</p> <p><u>3. DESCRIPTION OF ACTION TO BE COMPLETED</u></p> <p>a/ Disassemble wing tip of a glider.</p> <p>b/ Wash, with extraction naphtha, the spar end at wing tip connection.</p> <p>c/ Inspect the condition of spar end, and of the pin installed in spar end at the detachable wing tip connection, check that no debonding of pin flange from composite occurred.</p> <p>d/ Put the attachment, prepared according to Fig.1, on the pin.</p> <p>e/ Moving the attachment up-and-down /force applied at attachment tip must be within 8 to 10 kg/ observe the connection : pin flange - composite spar end, by means of magnifying glass with magnifying power of 3 minims. Pay attention if the pin flange does not shift in relation to composite spar end.</p> <p>f/ Assemble wing tip.</p> <p>g/ Observe the mating of /wing tip/ connection, when moving fluently up-and-down, wing caught by the tip.</p> <p>No clatter is permissible.</p> <p>h/ The described above action is to be completed on both, right and left wing.</p> | |

a/ Gliders, on which a play has been found, must be taken out of service, till appropriate repair will be done.
