GFA AD 474

GFA AIRWORTHINESS DIRECTIVE

DG-500 M

Inspection, modification and possible replacement of the propeller

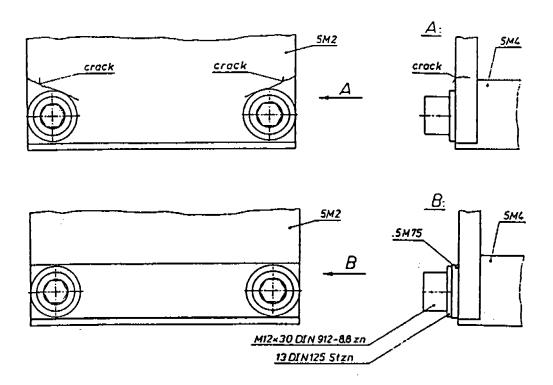
The critical areas (at the lower end) of the propeller mounting plate must be inspected for cracks. To accomplish this first remove the bolts at the front face of the propeller mounting plate including washers, then clean the plate with a cloth. Now have a close look at the surrounding of the fixing bolts and the edges (s. sketch) using a magnifying glass (magnification min. 5x). Due to remains of lubricant soaked into the cracks they are easy to detect.

Because cracks might also start from the impressions of the washers check this area very carefully. If cracks are detected or only suspected the propeller mounting plate must be replaced by a new part 5M2.

Moreover an aluminium plate 5M75 must be inserted between propeller mounting plate and washers for better stress distribution. Use longer bolts M12 x 30 DIN912-8.8zn instead of existing bolts to fix the propeller mounting plate.
