**GFA AD 480**  
(ISSUE 2)

## GFA AIRWORTHINESS DIRECTIVE

- TYPES AFFECTED:**
- DG-100
  - DG-100 Elan
  - DG-100G
  - DG-100G Elan
  - DG-200
  - DG-200/17
  - DG-200/17 C
  - DG-400
- SUBJECT:** Inspection and adjustment of the airbrake system.

**DG-Flugzeugbau GmbH**Im Schollengarten 20  
D-76646 BruchsalTechnical NoteNo. 301/18  
No. 323/9  
No. 826/34

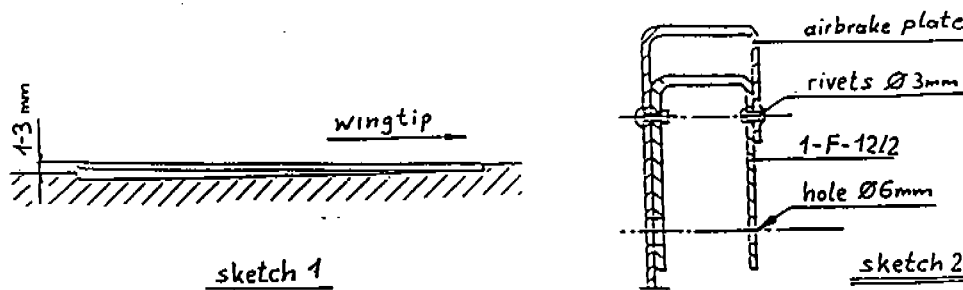
The airbrakes must retract at their outboard end first. When the airbrake cap is flush with the wing surface at the outboard end, the inboard end must be 1-3mm (0.039-0.118in) above the wing surface (s. sketch 1).

If not, modify as follows. With the modification a value of 1-3mm shall be adjusted.

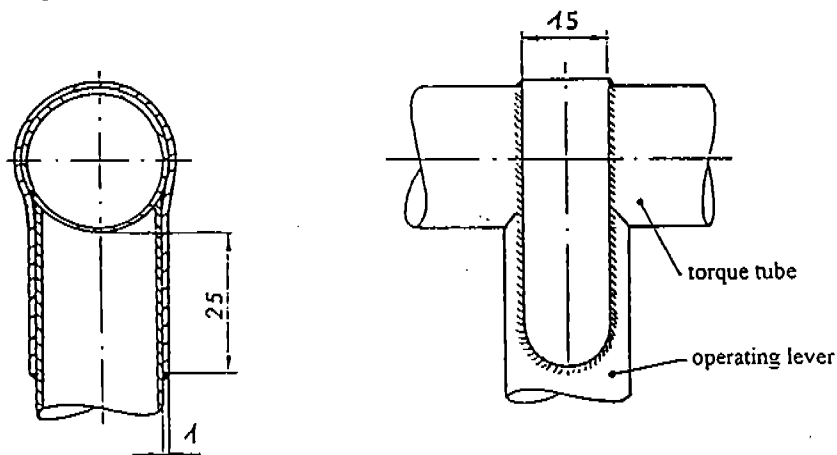
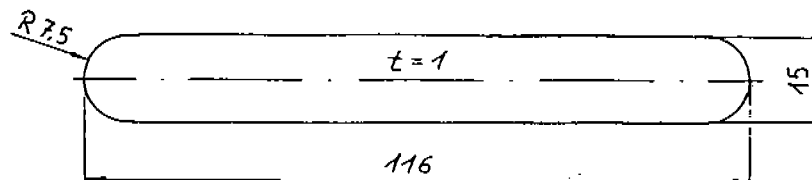
Sheet metal 1St12/2

Prior to the next flight the airbrake torque tube in the fuselage must be inspected. Check the welded joint to the operating lever on cracks or deformation when locking and unlocking the airbrakes on the rigged airplane. The airbrake torque tube can be reached through the inspection hole in the fuselage. For inspection of the welding joint use a mirror and a magnifying glass (magnification min. 5x). In case of doubt remove torque tube for closer inspection.

If necessary the welded joint of torque tube and operating lever must be reinforced by welding an additional steel sheet 1-St-12/2 made of material 1.7734.4 (s. sketch). Visible cracks or other defects of the original joint must be repaired first. All welding must be done with the TIG-welding system (tungsten inert gas) using welding wire 1.7734.2. Where welding is to be done cadmium plating or painting must be removed first by sandblasting.
