**GFA AD 483**  
(ISSUE 1)

### GFA AIRWORTHINESS DIRECTIVE

**TYPE AFFECTED:** PW-5 Smyk

**SUBJECT:** Miscellaneous Service Bulletins.

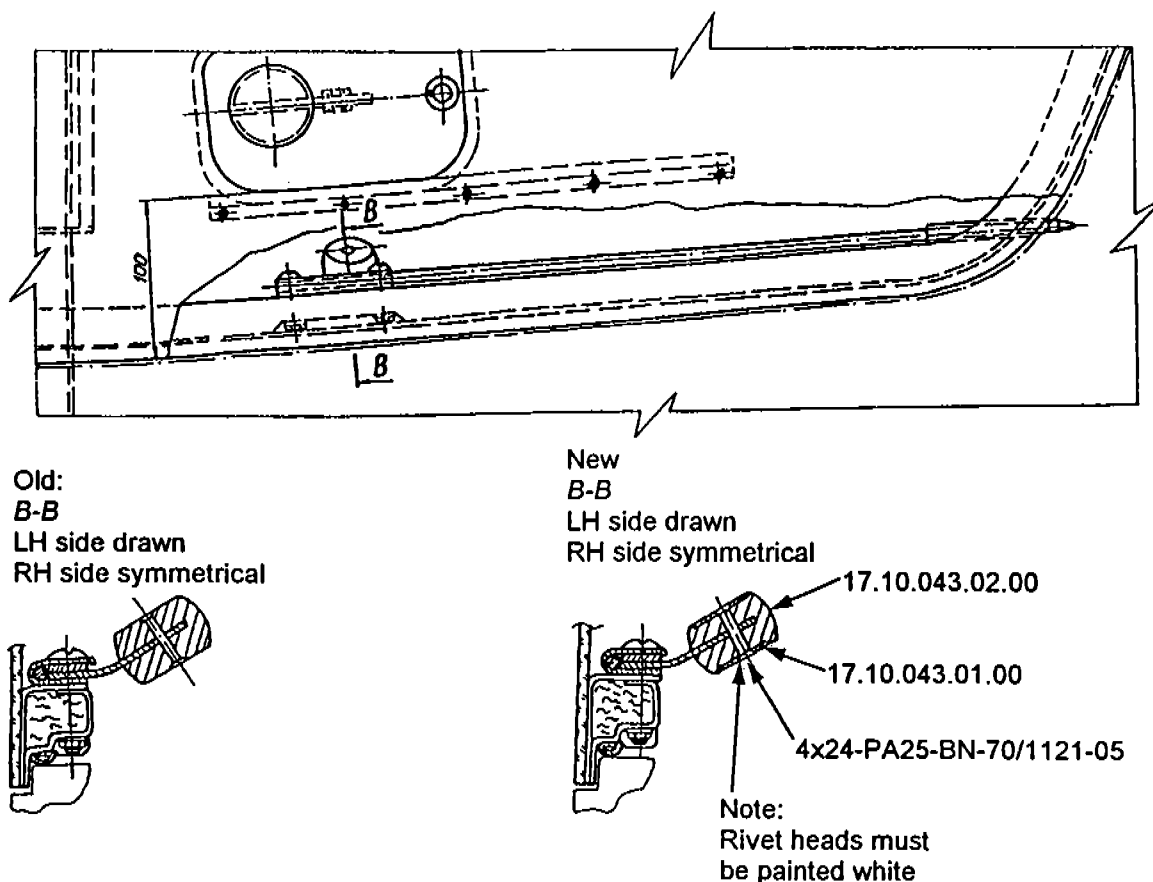
FIGURE 1 CANOPY HANDLE REPLACEMENT

4. At the next Annual Inspection after 30 September, 1998 the canopy locking handles must be replaced on serial numbers up to 17.08.018 (except S/N 17.08.011). The new handles must be installed in accordance with Figure 1. Parts must be obtained from the manufacturer.

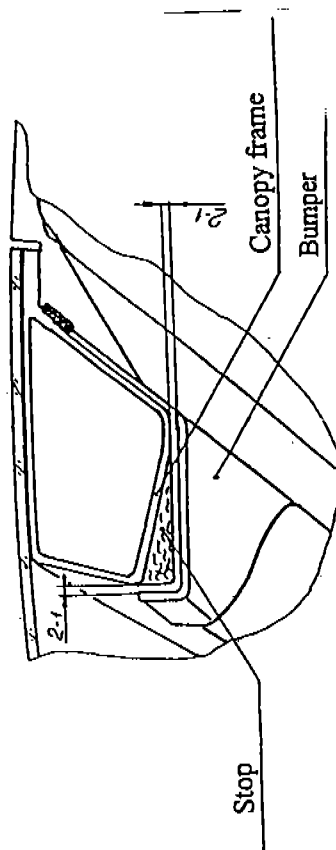
Sketch 2

Due to several cases of improper shape of the PW-5 glider canopy frame profile as compared with the design documentation which results in mismatching of the canopy frame and fuselage bumper, proceed as follows:

Improve the shape of the rear part of the canopy frame (within the plane of symmetry over the length of overlapping beyond the bumper in the fuselage), making a stop by application a layer of the EP-53+Z1 compound with admixture of flock and carbon black - refer to Sketch 2. When applying, maintain a smooth pathway between the stop and canopy frame.

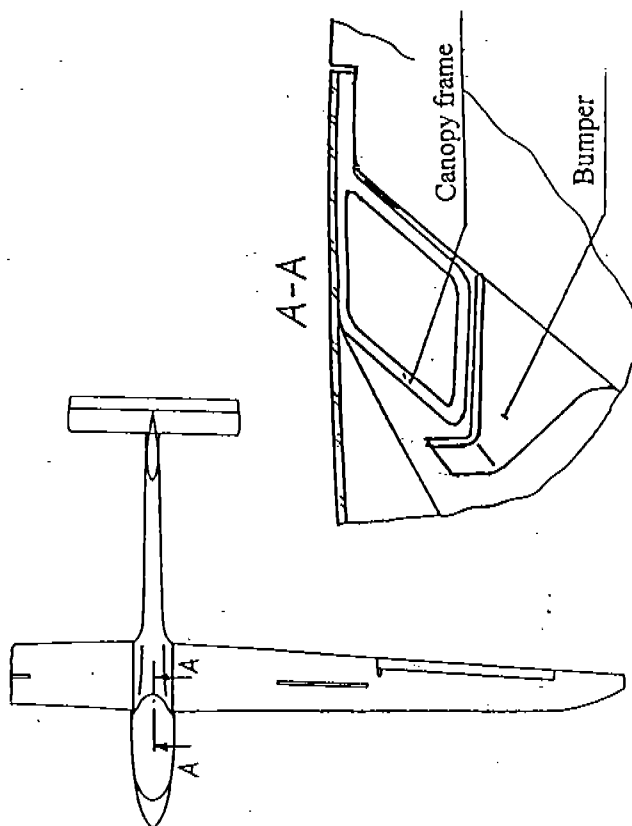
Sketch 1

Carry out a single inspection of the mating components for technical condition and make sure whether the canopy frame overlaps the bumper as shown on Sketch 1.
