## GFA AIRWORTHINESS DIRECTIVE

- TYPE AFFECTED:** Stemme S10 Serial Numbers 10-03 to 10-63  
Stemme S10-V Serial Numbers 14-002 to 14-026 and transformed aircraft 14-012M to 14-063M.
- SUBJECT:** Cracking of the rear horizontal stabiliser mount.
- BACKGROUND:** Overseas experience has shown that cracks may occur in the rear tailplane mounts.
- DOCUMENTATION:** Stemme S10 Service Bulletin A31-10-022 which forms part of this AD. Note that only pages 4 through 6 have been included as pages 1 through 3 are the German language version.
- ACTION REQUIRED:**
1. Before next flight the rear tailplane mount must be inspected for cracks in accordance with item 5.1 of Service Bulletin A31-10-022.

| | - Cracks in rear Horizontal Stabilizer Fitting - | | <b>A31-10-022</b> |

Cracks in rear Horizontal Stabilizer Fitting / Project No.: 10-279

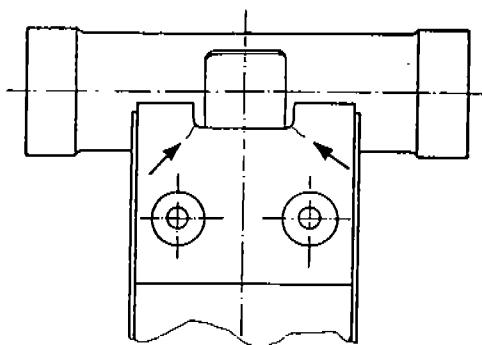
Cracks were detected in some S/Ns of the Type in the rear fitting of the horizontal stabilizer (HS). It is believed that they were caused by internal residual stress after welding, superimposed by operational loads. Cracks developed after long periods of operation compounded by non-optimal component design.

The presence of cracks and their extent must be ascertained previous to the next flight. Any part with a crack length of 7 mm or over, detected using a five-fold magnifying glass must be replaced previous to the next flight.

As the fuselage- and elevator-sided fitting components are produced in pairs, both parts should either be replaced together or the casing of the fuselage-sided fitting should be replaced solely (utilizing its component parts, i.e. axle, bearings etc.). Otherwise problems concerning fitting of pins and bushings are to be expected.

Attention: Welding damaged casings is not permitted!

Only new casings that have been optimized regarding design, material and heat treatment may be used during repair.

The following steps should be taken to exchange the casing: Remove the pin 10LS-HH05 on one side. Remove bolt M5x40 from the center of the casing and press out bushing 10LS-HH06. Press out axle 10LS-HH04. Remove bearing 10LS-HH09 from the opposite side. Press bearing into the new casing and ensure that it has reached the base. Further installation to be carried out in the reverse order.
