GFA AIRWORTHINESS DIRECTIVE

- TYPE AFFECTED:** AMT 200 Super Ximango.
- SUBJECT:** Electric system - Inspection of Stator and Ignition Cables of Rotax Engines 912 A2.
- BACKGROUND:** Due to an unfavourable influence of some chemical reactions, improper installation or maintenance, the insulation material of the stator cables of the alternator could be damaged which might lead to problems with the ignition.

ALERT SERVICE BULLETIN

Title: ELECTRIC SYSTEM – INSPECTION OF STATOR AND IGNITION CABLES OF ROTAX ENGINES 912 A2

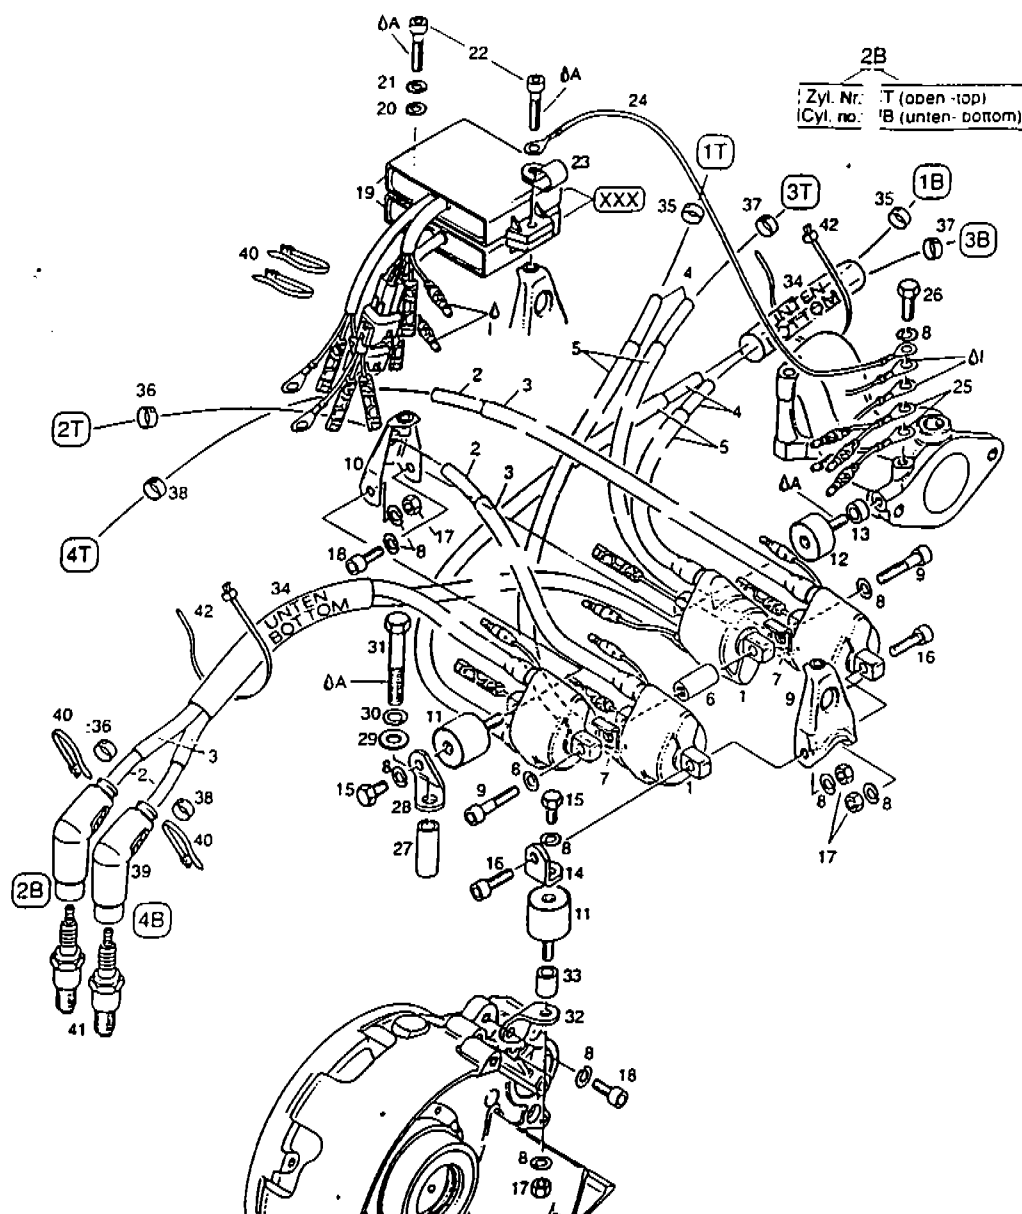
Figure 1

- 2.1** Check the ignition unit for mechanical, thermal and chemical damages (See figures 1 and 2).
- 2.2** Check all cable connections, all ground connections, charging and shorting cables and grounding cables for tight fit, good contact, corrosion and safety; repair as necessary.
- 2.3** Verify shielding of cable assemblies for damage, for grounding contact and safety.
