GFA AD 505
(ISSUE 1)

GFA AIRWORTHINESS DIRECTIVE

SUBJECT: Flight controls - Inspection/Replacement of the knurled nut at the rear control stick.

Subject: Inspection/ Replacement of the knurled nut at the rear control stick

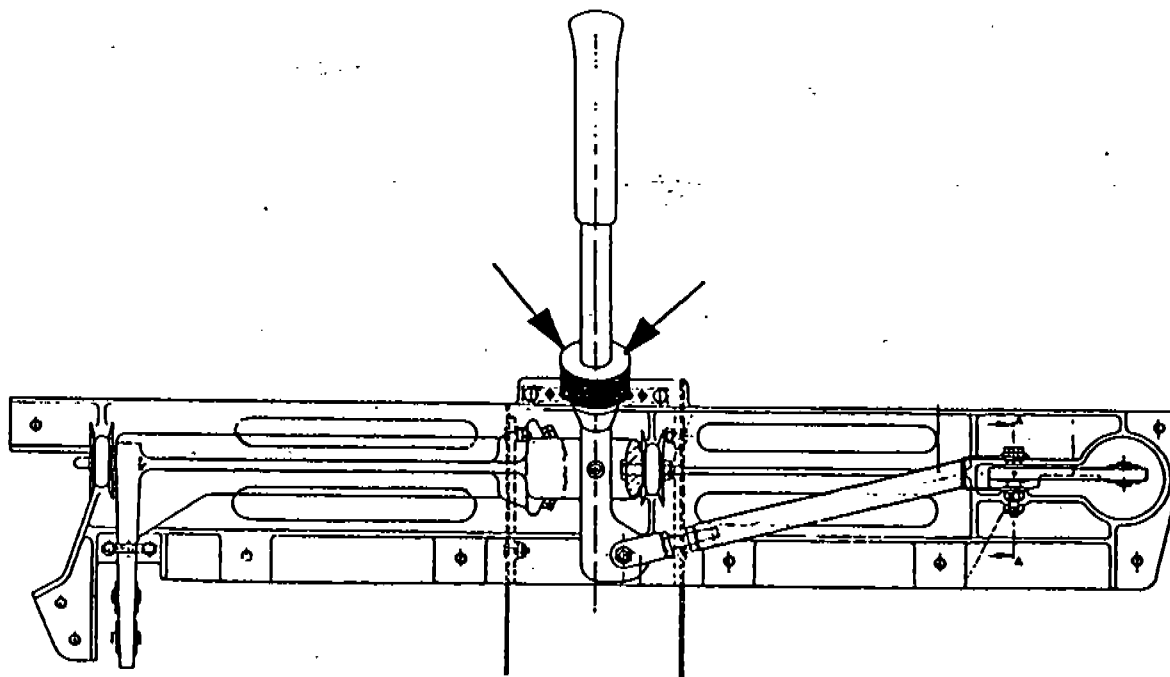
Background Information: Single cases had been reported to GROB, where the fastening nut (knurled nut) was cracked. Previous investigations showed, that these damages may be caused by improper handling i.e. fastening the nut too tight. As a precautionary action an inspection or replacement of the knurled nut is mandatory.

1. The knurled nut must be checked for damage, especially for cracks on the upper side of the nut. If the nut is found damaged or cracked, the nut must be replaced immediately.

2. The inspection must be repeated before the first flight of a day, until the knurled nut is replaced.
3. The knurled nut at the rear control stick must be replaced for a new knurled nut made from stainless steel.

Material: The new knurled P/N 103-4205.03/2 is attached to the Service Bulletin.
