GFA AIRWORTHINESS DIRECTIVE

- TYPE AFFECTED:** AMT 200 Super Ximango Serial Numbers 200.040, 200.045 to 200.070.
- SUBJECT:** Exhaust pipe movement.
- BACKGROUND:** A downwards movement of the exhaust pipes and the muffler caused by engine vibration is possible. As this displacement reduces the ventilation space between muffler and the inside of the lower engine cowling the lower engine cowling may be damaged.

SERVICE BULLETIN

Title: EXHAUST SYSTEM - MODIFICATION OF EXHAUST PIPE CLAMPS.

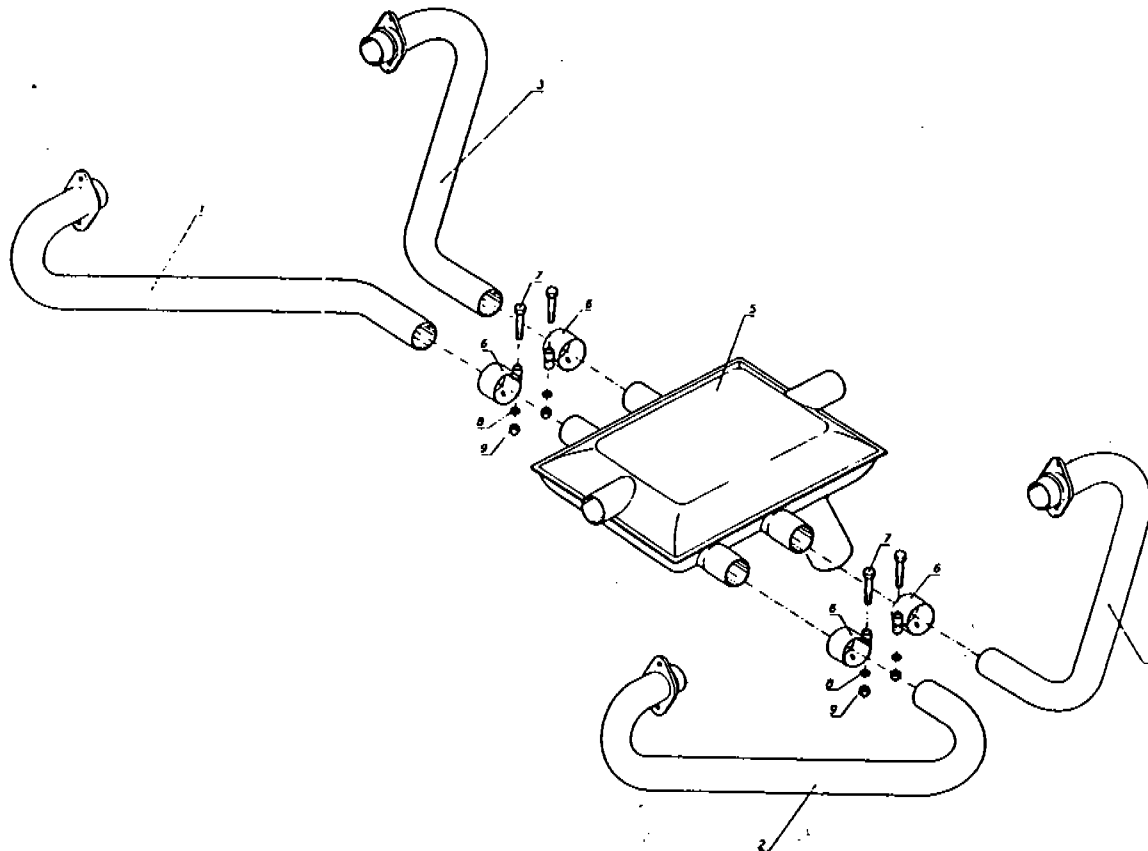
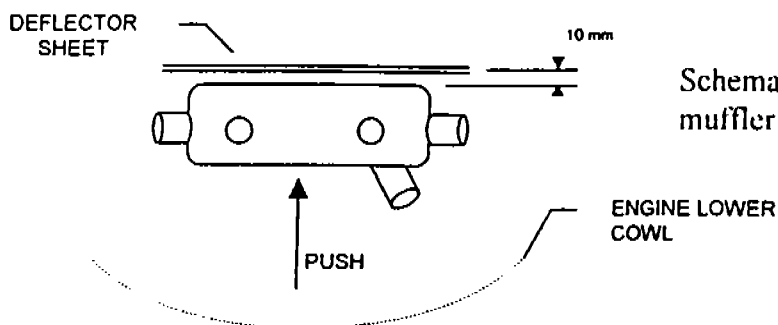
Figure #1

To prevent the possibility of a down movement of the exhaust pipes P/N 61632, 61633, 61634 and 61635 together with the muffler P/N 61624 caused by engine vibration. This movement reduces the ventilation space between muffler and inside of lower engine cowl and causes burning stains on lower engine cowl.

2.1.2 Loosen the four screws P/N AN 5C 11A (see item 7 figure #1) and move the muffler P/N 61624 (see item 5 figure #1) up until the distance between deflector sheet P/N 61629 (screwed to engine mounts) and muffler is about 10 mm.

2.1.4 Drill each clamp P/N 61625/1 (see item 6 figure #1) together with exhaust tube P/N 61632, 61633, 61634 and 61635 (see items 1, 2, 3 and 4 figure #1) with a drill Ø 3,2 mm (Ø 1/8"). See these procedures in the figure #2.
