GFA AIRWORTHINESS DIRECTIVE

SUBJECT: Elevator mass balance.

SUBJECT: Horizontal tailplane – elevator mass balance

WORKING INSTRUCTIONS FOR INSTALLING ELEVATOR MASS BALANCE

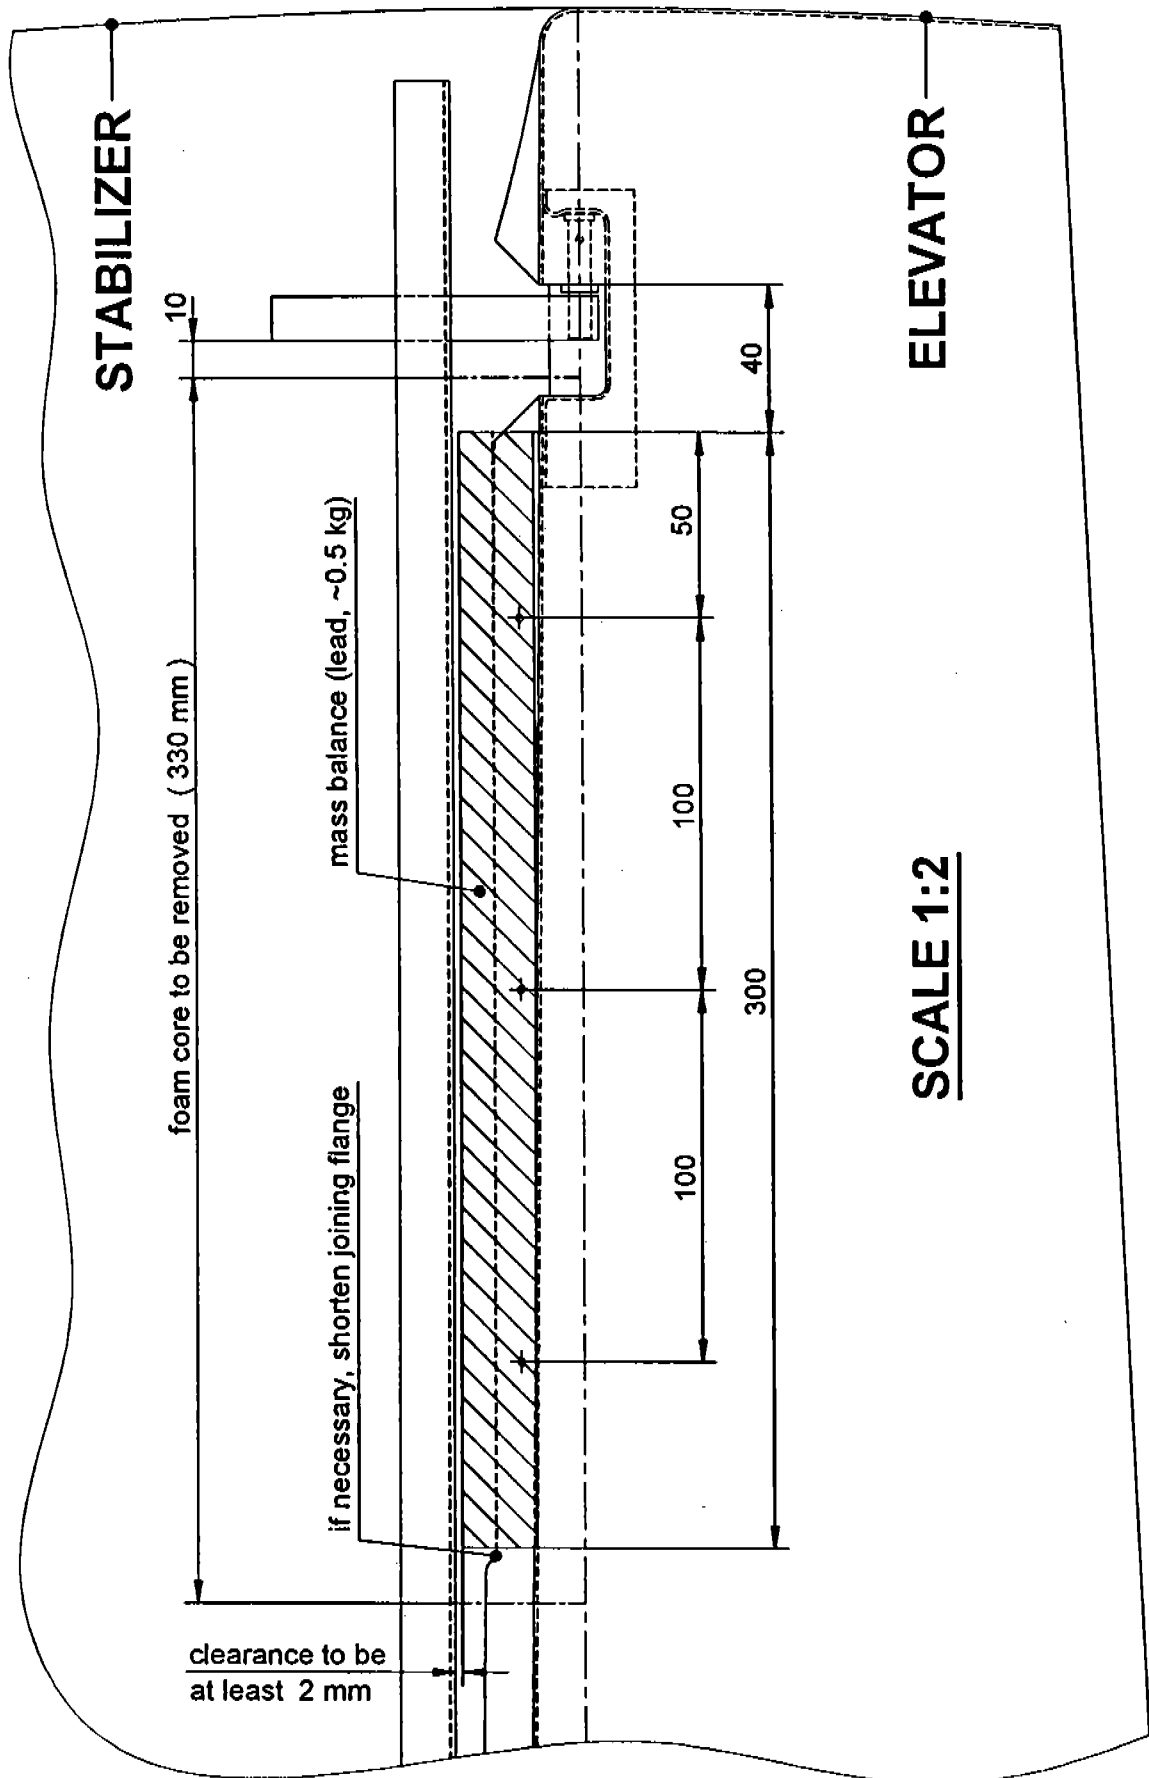
glass cloth and foam
to be removed

1. Remove elevator halves.
2. Stabilizer
 - a) Remove glass cloth and foam core from shroud up to the web
- see also page 02 and 03.
 - b) Reinforce shroud and web by applying additional carbon/glass cloth layers – see page 03.
