GFA AD 510
(ISSUE 1)

GFA AIRWORTHINESS DIRECTIVE

Subject: Air brake locking in fuselage

Effectivity: Sailplane LS4, versions LS4 and LS4-a,
serial numbers between 4000 and 4852

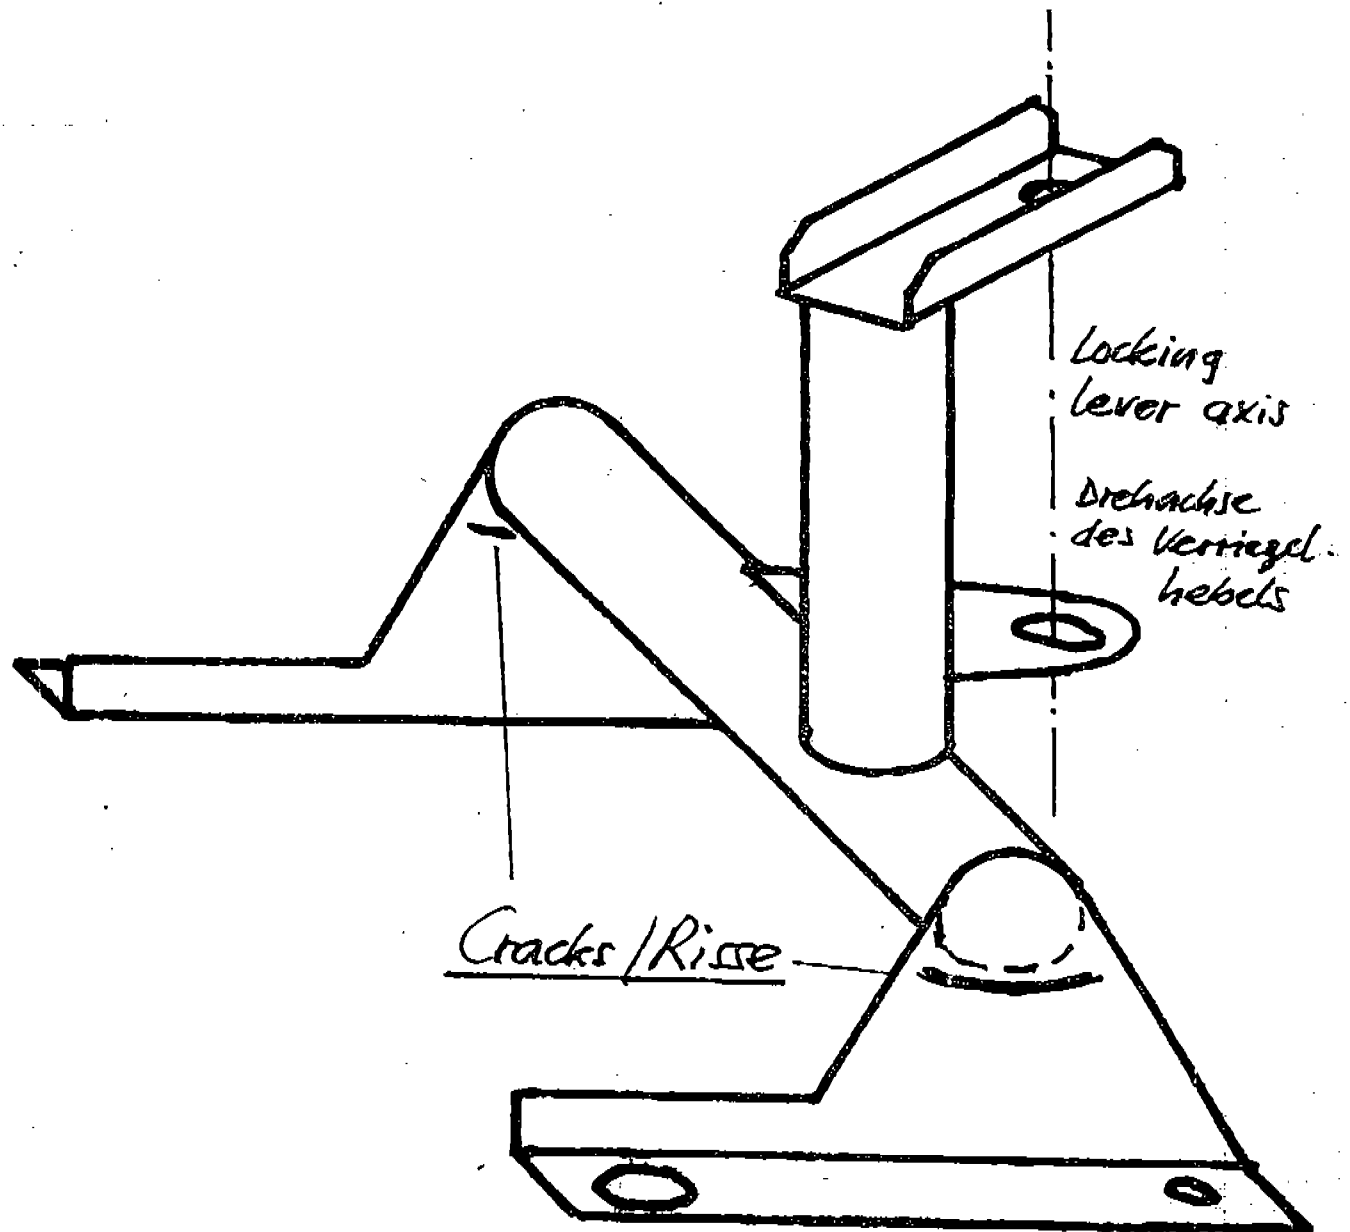
2. Check both fixing angles at this air brake locking bracket for lateral deformation (indication by cracks in paint or paint chipping off) and/or cracks in the welding area next to the tube. See sketch of air brake locking bracket.

Reason: Due to possibly improper preflight checks, asymmetric adjustment of pushrods during exchange of L'Hotellier ball snap joints or uneven locking adjustments, the air brake locking bracket may be under long time asymmetric load, resulting in fatigue fracture at the lateral fixtures.

Lagerbock der Bremsklappenverriegelung rumpfseitig auf dem Fahrwerkskasten (Bereich auftretender Risse markiert)

Air brake locking bracket on landing gear box (Crack region marked)

- Material and Instructions:
1. With sailplane rigged, check air brake locking bracket on rear landing gear box for lateral movement during air brake locking.
 2. Check both fixing angles at this air brake locking bracket for lateral deformation (indication by cracks in paint or paint chipping off) and/or cracks in the welding region to the tube. (See sketch on page 2)
 3. Only with cracks or deformation existent, disassemble the bracket. Repair and modification required according to drawing 3R6-27b.
