THE GLIDING FEDERATION OF AUSTRALIA

GFA AD 513
(ISSUE 2)

TYPE AFFECTED: LS-6, all models, all serial numbers

SUBJECT: Obstruction of emergency canopy jettison.

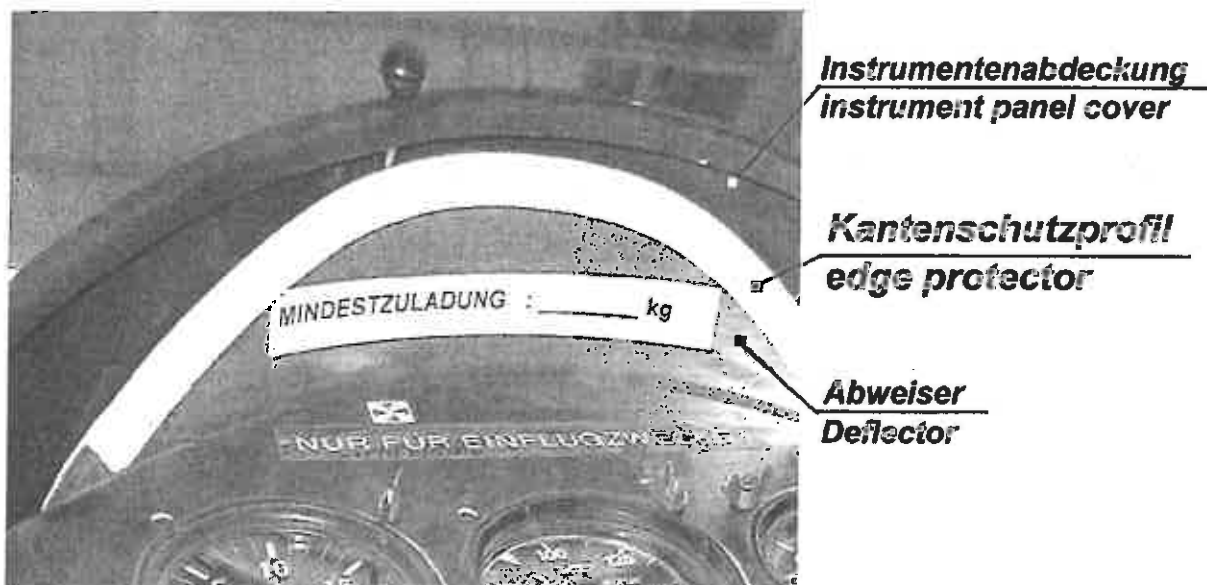
Deflector with edge protector:

Reason: A deflector on the upper instrument panel edge avoids possible jamming of the instrument panel between the canopy mounted panel cover after actuation of the canopy emergency jettison.

When the plane is already equipped with a reflector according to TB 6036, this should be shortened by 10 mm (0.4 in) and be covered with an edge protector. Details and view see working instruction.

1. Drill blind rivets. If need be, unscrew upper instruments (Hexagon head 2.5 mm und ratchet with 7mm socket) and place them on top of the second row.
2. Mark new fixing holes 10mm (0.4 in) offset from originals and drill. This enables to use the existing holes at the instrument panel edge.
3. Shorten straight edge of deflector by 10 mm, soften edge and paint black. Maximum depth of deflector after trimming is 100 mm (3.94 in).
4. Rivet deflector back to top of instrument panel, facing towards the pilot (Blind rivets Ø 4mm*6.5, large washers Ø4.3 * 12 * 1mm DIN 9021-St).
5. Push edge protector (as long as instrument panel allows) onto deflector edge.

Should the instrument panel cover be too short to allow the protector to fit underneath, contact manufacturer stating model and serial number.
