# GFA AD 515

## GFA AIRWORTHINESS DIRECTIVE

**TYPE AFFECTED:** LS-8, all models, all serial numbers.

**SUBJECT:** Obstruction of emergency canopy jettison.

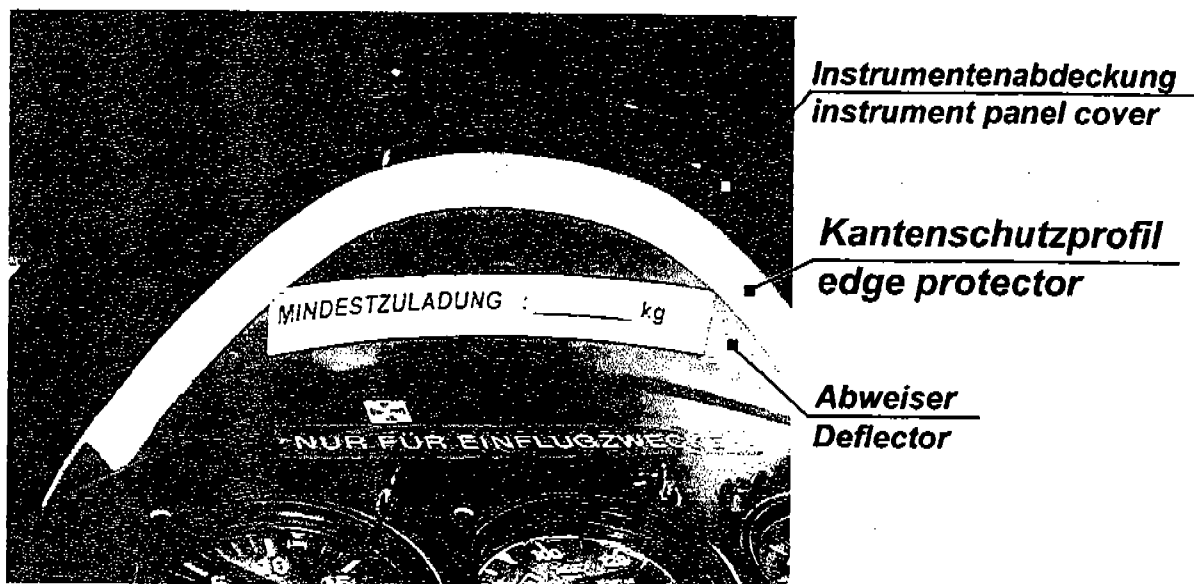
### Deflector with edge protector:

Reason: A deflector on the upper instrument panel edge avoids possible jamming of the instrument panel between the canopy mounted panel cover after actuation of the canopy emergency jettison.

1. Drill blind rivets. If need be, unscrew upper instruments (Hexagon head 2.5 mm und ratchet with 7mm socket) and place them on top of the second row.
2. Mark new fixing holes 10mm (0.4 in) offset from originals and drill. This enables to use the existing holes at the instrument panel edge.
3. Shorten straight edge of deflector by 10 mm, soften edge and paint black. Maximum depth of deflector after trimming is 100 mm (3.94 in).
4. Rivet deflector back to top of instrument panel, facing towards the pilot (Blind rivets Ø 4mm\*6.5, large washers Ø4.3 \* 12 \* 1mm DIN 9021-St).
5. Push edge protector (as long as instrument panel allows) onto deflector edge.

Should the instrument panel cover be too short to allow the protector to fit underneath, contact manufacturer stating model and serial number.
