GFA AIRWORTHINESS DIRECTIVE

TYPE AFFECTED: ASW 27. All models and serial numbers.

SUBJECT: Check of control circuit clearance inside the fuselage tail boom to fin intersection.

DOCUMENTATION: Alexander Schleicher Technical Note ASW 27 No. 5 which herewith becomes part of this AD.

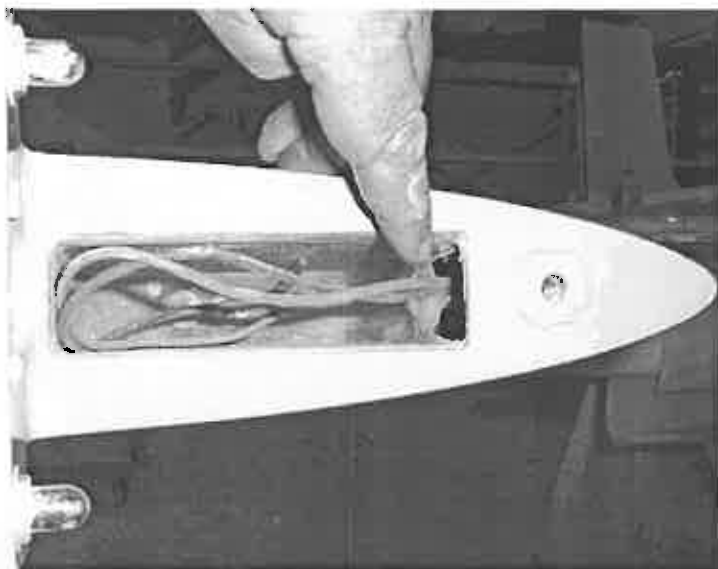
- Action:**
- 1) De-rig the horizontal tailplane, look through fin ballast box as shown in Fig. 1A and check the clearance left and right of the mass balance weights, see Fig. 1B. A strong light which is held to the outside of the fuselage to fin intersection close to the critical area improves the visibility remarkably.
NOTE: The critical situation is reached, when the elevator actuator is fully down. When the clearance (including bolt head and nut or bolt end) is about symmetric and 2,5 mm (1/10 inch) wide, no further action is needed.

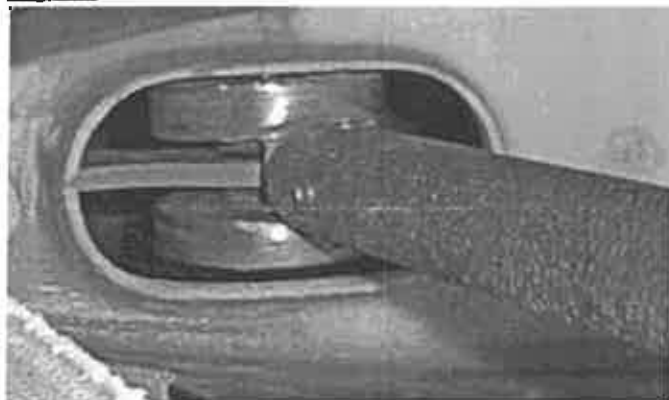
Fig. 1B

- Compliance:** Until October 31st, 1999.
- Reason:** An ASW 27 owner in Sweden reported light jamming in one flight and abandoned the take-off. Rubbing of the 90° lever with its attached mass balance lead weights and connecting bolt against the cut-out of the lower fin rib has been determined as the only likely cause.
