GFA AIRWORTHINESS DIRECTIVE

- TYPE AFFECTED:** ASH 26 E. All serial numbers.
- SUBJECT:** Inspection and exchange of the muffler.
- BACKGROUND:** The high grade steel plate of the earlier mufflers turned out to be insufficiently resistant for the inner areas. One muffler showed cracks in the inner area after about 45 hours of operation. A superior material has been used since 1996 and the stronger mufflers are marked with an X at the front plate.

Subject: Inspection and exchange of the exhaust damper of the power-plant. Amendment and corrections to the manuals.

Affected: ASH 26 E, Data Sheet No. 04.883, all serial numbers.

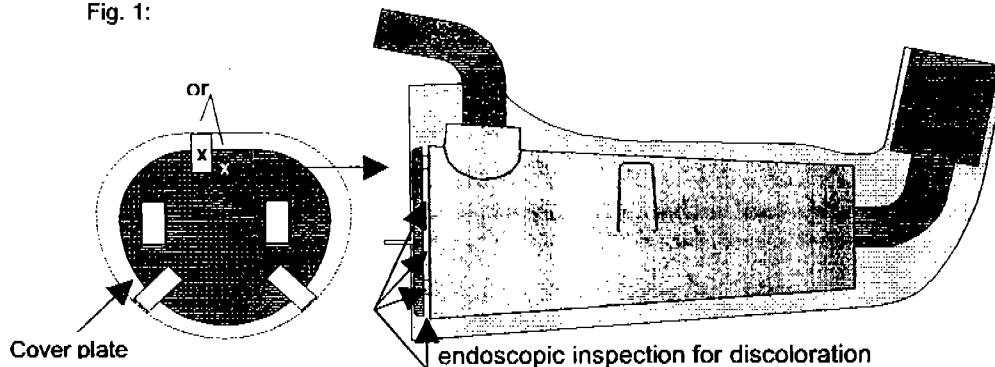
Compliance: Prior to the next engine flight all powered sailplanes must be inspected to make which version of the exhaust damper has been installed. The upgraded exhaust dampers were marked with the letter 'X'. This marking is located on the front side as shown in Fig. 1:

Where the operating time of the exhaust damper is above 40 hours, the front side of the exhaust damper behind the cover plate (see Fig.1) must be additionally inspected for tempering coloration using an endoscope. If this inspection does not reveal any discoloration from the golden-yellow basic coloring changed to a gray or bluish coloration so, a further engine operation in another two hours intervals is allowed. This inspection must be repeated in 2 hours intervals up to a maximum operating time of the exhaust damper of 60 hours.

The high grade steel plate from which the first exhaust dampers were made from, unfortunately turned out to be insufficiently resistant for the inner areas. In one case an exhaust damper system showed cracks in this inner area after about 45 hours operation. As of 1996 the factory serial production used a superior material for the inner parts of exhaust damper. These upgraded exhaust dampers were marked with an 'X' at the front plate. At the time yet there was no reason for exchanging the earlier version.

If damages or discoloration are found during any of the above inspections, the exhaust damper must be exchanged prior to the next engine flight.

a) If the inspection shows that an exchange of the exhaust damper becomes necessary, the customer must obtain a new exhaust damper from Schleicher GmbH. The part must be installed in accordance with the instructions supplied with it.
