## GFA AIRWORTHINESS DIRECTIVE

**SUBJECT:** Cracks in the aileron steel pipe spar around the welded hinge bushings.

<b>GFA AD 519</b>	<b>ISSUE: 1</b>	<b>21. October 1999</b>	<b>Page 2 of 4</b>
-------------------	-----------------	-------------------------	--------------------

SCHEIBE- Flugzeugbau GmbH August- Pfaltz- Str. 23 85221 Dachau LBA-approval I-B 3/I-EB2	<b>Service Bulletin 653- 73</b>	<b>SF 25 B / C</b> <b>TCDS.: 653</b> Page 1 of 2
--	---------------------------------	--

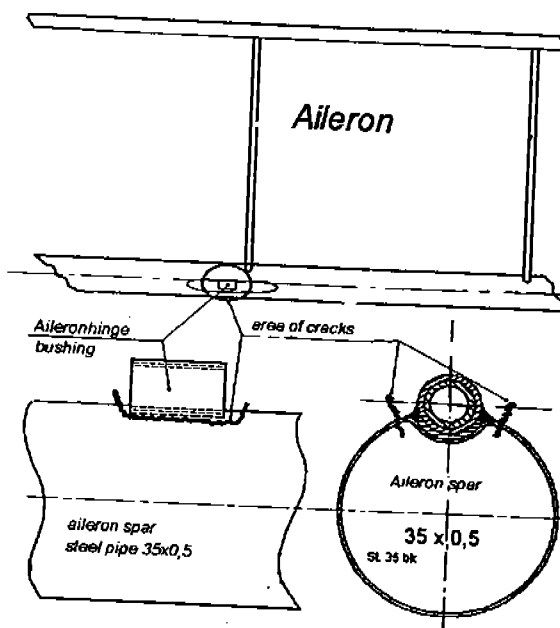
**Reason:** During inspection of a motorglider one aileron hinge was found to be broken out of the aileron steel pipe spar. On one aileron hinge bushing of another motorglider cracks have been detected around the hinge bushing weld seam (see following sketch)
