**GFA AD 522**  
(ISSUE 1)

## GFA AIRWORTHINESS DIRECTIVE

**TYPE AFFECTED:** DG-500/22 ELAN, DG-500 ELAN ORION, DG-500 ELAN Trainer, DG-500/20 ELAN. All serial numbers up to 5E203.

**SUBJECT:** Elevator Control in the Vertical Fin.

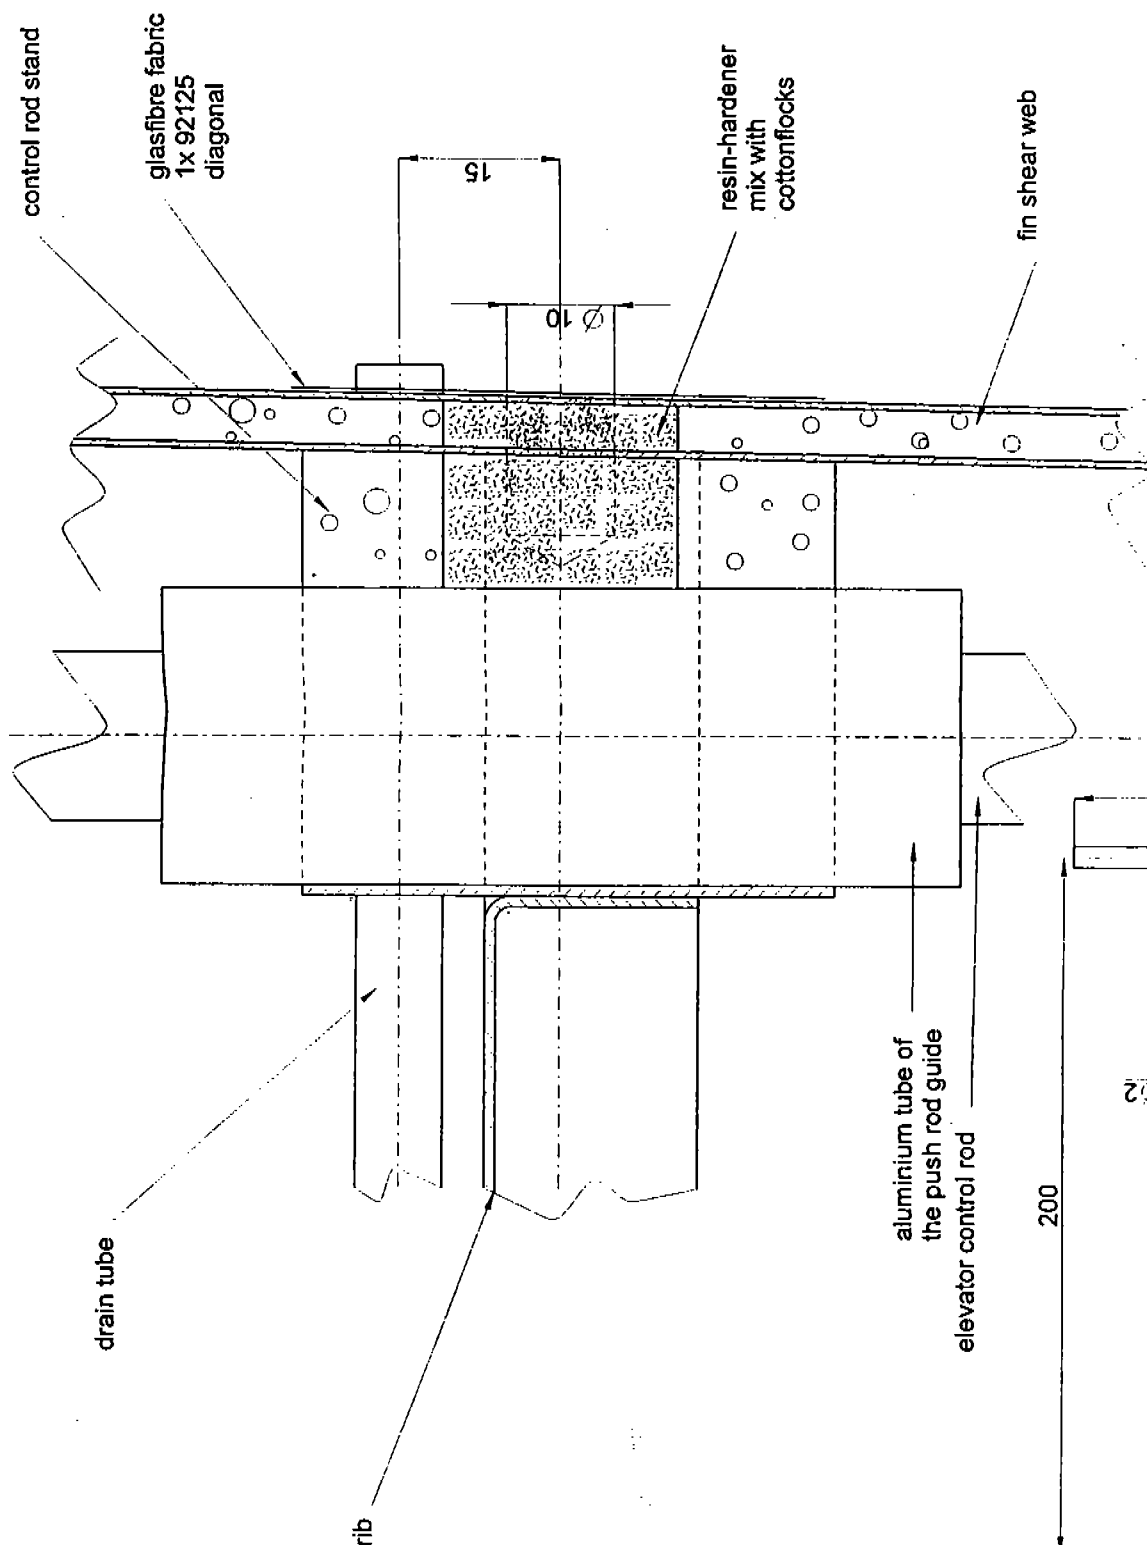
5L36
Schweißen nach Arbeitsanweisung SA 1		Gez.	24.09.89 W. Ditzel		
		Gepr.			
		Norm.			
		Maßstab	2:1	Elevator control Stiffening of the Control rod stand TN348/12, 843/12	
		Nicht ohne Toleranz- angabe nach:			
Ausg.	Änderung	Am.	Tag	Name

Reason : On one DG-500 the push rod guide of the elevator control rod in mid-point of the vertical fin came loose. If the guide slips up or downwards this may cause hard movement of the elevator control.  
The reason that the guide may come loose is that the foam core of it's stand may be compressed by a very high load. To prevent such problems the foam core must be stiffened using resin thickened with cottonflocks.

**Stiffening of the stand for the elevator control pushrod guide in the vertical fin**  
Details see drawing 5L36

6. Prepare a dia. 2mm pianowire according to the sketch on drawing 5L36.
7. Scratch out the foam 6mm (.24in.) around the hole, from both the shear web and the stand. Enlarge this hole up to the aluminium tube of the push rod guide. No foam shall remain at the tube in the area of the hole.

10. Mix cottonflocks to the resin and fill the prepared hole completely.
11. Cover the hole with a piece of glassfibre fabric style 92125 laid up diagonally 70mm (2.8 in.) wide and 50mm (2 in.) high.  
Gliders with fin battery installed: cut off the edge of this fabric at the drain hole so as not close the hole.

tool to remove the foam
