**GFA AD 537**  
(ISSUE 2)

**TYPE AFFECTED:** SZD-50-3 Puchacz.

**SUBJECT:** Inspection of fuselage front bracket console.

### MANDATORY BULLETIN No BE-048/SZD-50-3/2000 „PUCHACZ”

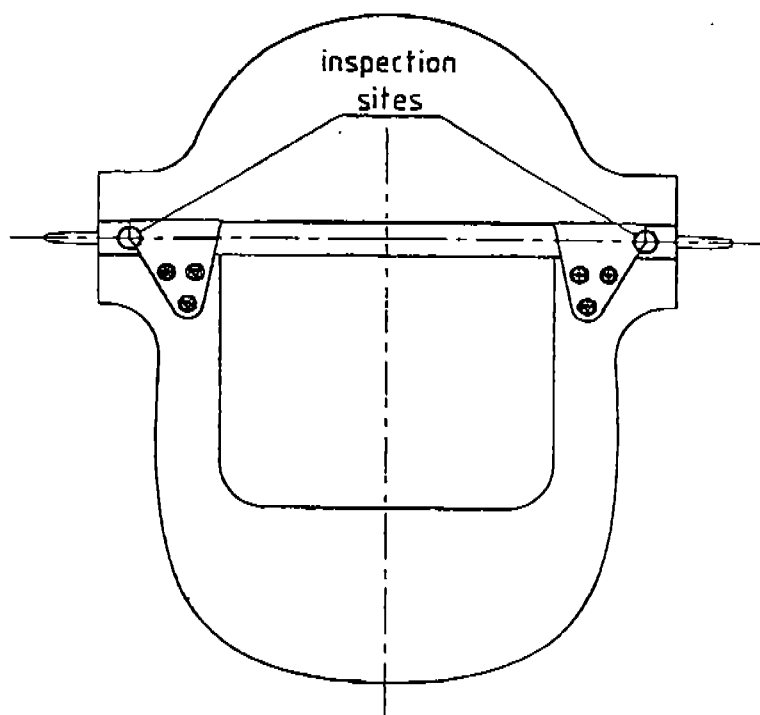
Front  
bulkhead view

Bulletin issued due to first information on cracks detected in the front bracket console, mounted on front bulkhead fuselage.

Inspection to be held at sites indicated in the following sketch, both on front and back side of fuselage front bulkhead.

1. Preparatory action at sites specified in a sketch.
  - Wash-out paint from the surface, and de-grease the latter with acetone
  - Remove impurity from console surface with wire brush.
  - Pre-check the specified sites with aid of magnifying glass of 5x magnification, at least.
2. In case of doubts, employ the non-destructive magnetic-flourescent, penetrant-flourescent or penetrant-colour method accepted by Airworthiness Authority.

| <p><b><u>4. FINAL CONCLUSIONS</u></b></p> <p>In case of finding on a console cracks above 3 mm, this plane should be withdrawn from operation, and producer is to be supplied by fax (No +48 33 812 37 39) with the following information:</p> <ul style="list-style-type: none"> <li>- glider Factory No,</li> <li>- year of production</li> <li>- total flying time</li> <li>- total amount of hour flown in aerobatics</li> <li>- location and size of detected crack,</li> </ul> <p>After collecting the necessary information, a Bulletin will be issued - one specifying the repair procedure.</p> <p><b><u>5. ENCLOSURES</u></b></p> <p>There are no enclosures to this Bulletin.</p> <p style="text-align: center;">- THE END -</p> | | |
