GFA AD 542
(ISSUE 1)

GFA AIRWORTHINESS DIRECTIVE

TYPE AFFECTED: SZD-50-3 Puchacz

SUBJECT: Replacement of wing-to-fuselage front fitting

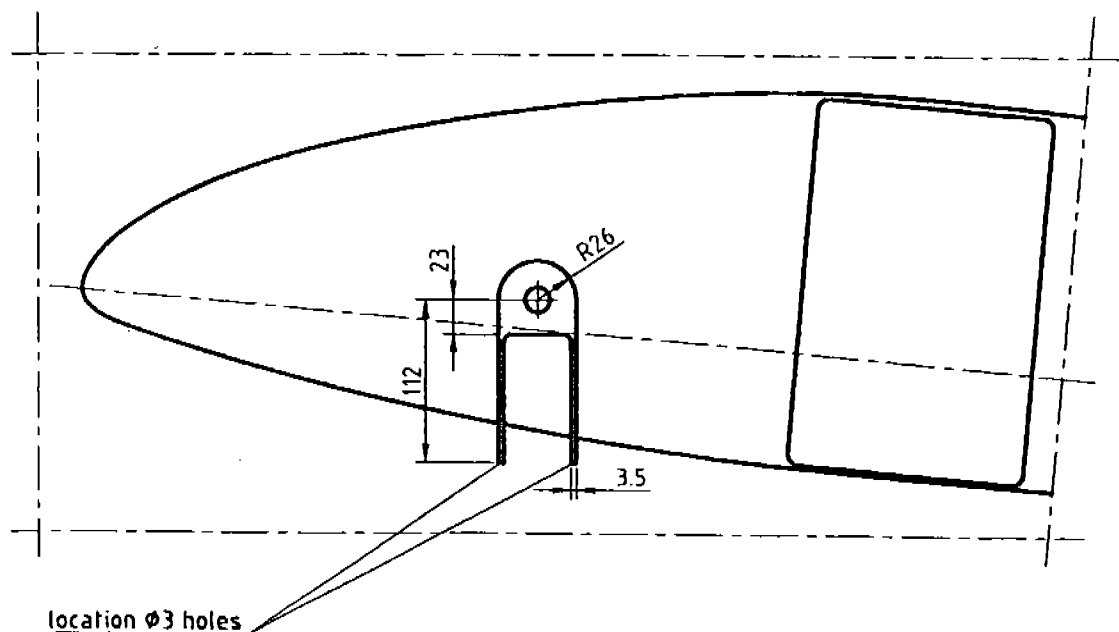
Bulletin issued due to cracks detected in console of the mounted to fore bulkhead fuselage front fitting.

Front fitting replacement must be made on each plane of SZD-50-3 "PUCHACZ" model on which, in inspection, a crack of length exceeding 3 mm has been found.

- Make a cut-out in fuselage skin, in accordance with following drawing.

To facilitate marking of cut-out contour, make a hole with 3 mm diameter drill in fuselage skin from inside, close to bulkhead.
