GFA AD 559
(ISSUE 1)

GFA AIRWORTHINESS DIRECTIVE

SUBJECT: Jamming of elevator control.

Title: FLIGHT CONTROL – INSPECTION OF ELEVATOR DRIVING ROD UNDER HORIZONTAL CONSOLE

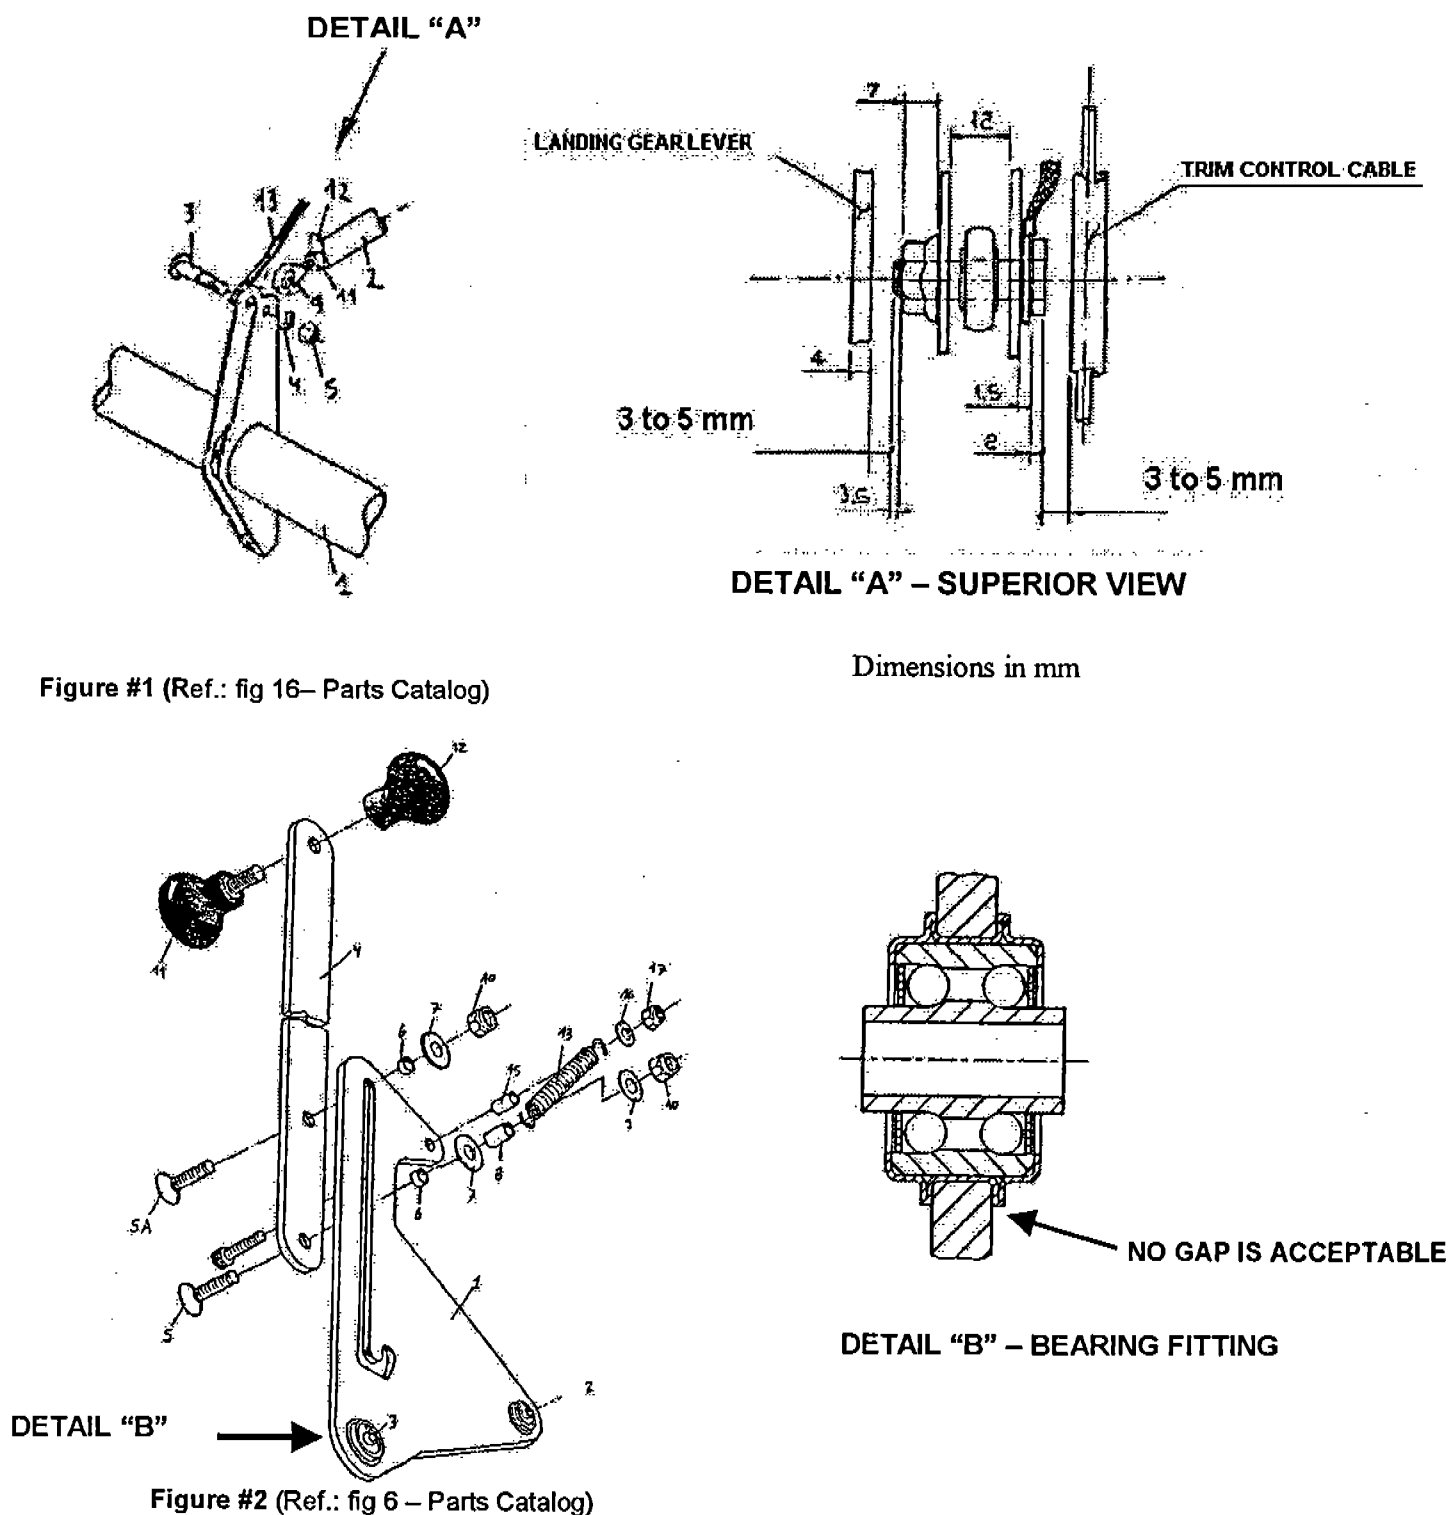
Bending or warping in main landing gear lever could result in chafing and/or interference with the elevator driving rod movement.

2.4 Push the control stick (elevator driving) slowly forward and check if the gap between landing gear lever (in retracted and caged position) and nut that fix the terminal rod of elevator driving is about 3 to 5 mm in accordance with detail "A" of figure #1.

2.5 Check if the gap between screw head and the trim cable cap is about 3 to 5 mm in accordance with detail "A" of figure #1.

2.7 Check if there are signs of chafing of nut (that fix the terminal of rod of elevator driving) in the landing gear lever P/N 15316; if there are signs of chafing, remove the support guide P/N 15315 and inspect its flatness and if there is gap in the bearing fitting (See detail B of figure #2). Replace non conformance parts .
