## GFA AIRWORTHINESS DIRECTIVE

**TYPE AFFECTED:** Glasfluegel Kestrel, all serial numbers.

**SUBJECT:** Airbrake actuating shaft.

**Airworthiness  
Directive  
2002-051**

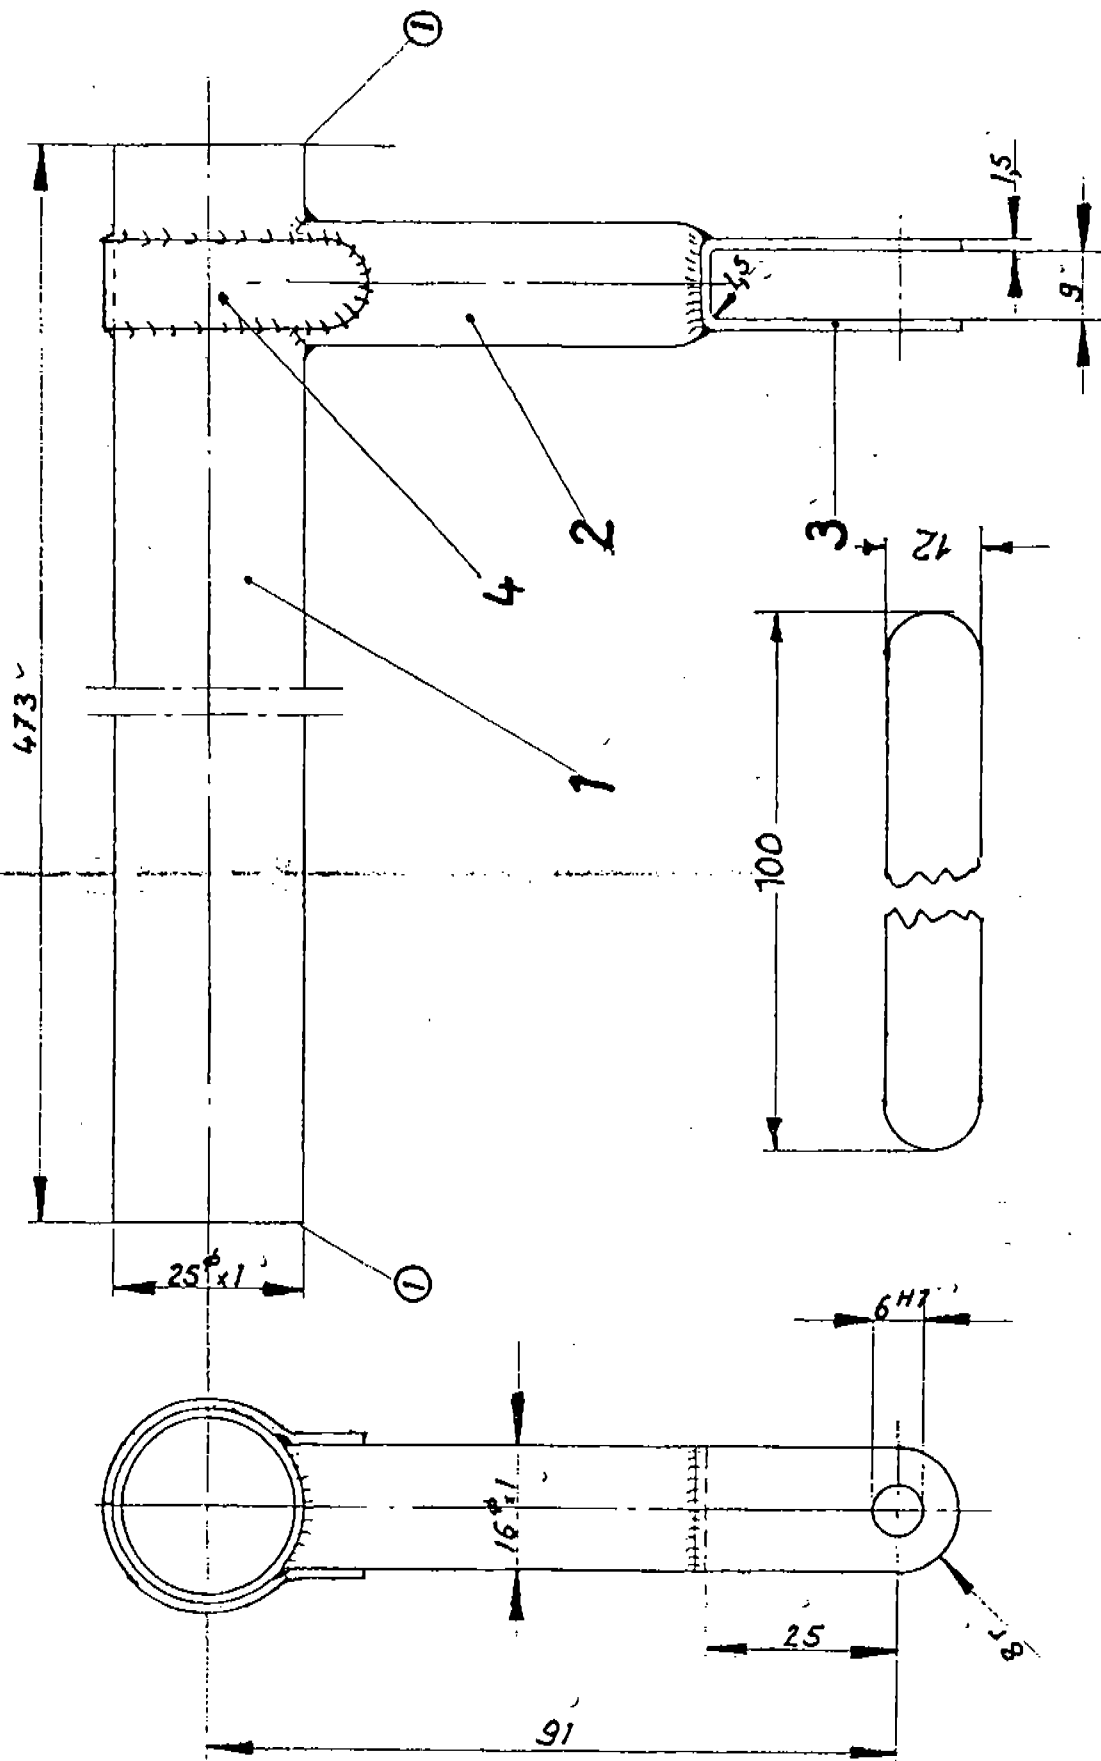
4. If damage is found during completion of step 1 or 3, the airbrake actuation shaft must be immediately removed. The welding seam area must be thoroughly cleaned and all paint removed. In case of visible deformation, the actuation lever must be heated and returned to the original position. Visible cracks may only be welded by a licensed aircraft welder within a licensed and appropriately equipped aircraft maintenance organisation. Afterwards no. 4 must be properly welded in accordance with drawing no. 401-56-3-1.  
Welding joints must be done with the WIG-inert protective atmosphere welding system with welding material 1.7734.2. Finally the actuation shaft must be finished with primer and paint RAL 7003. After assembly, you must check that both airbrakes are completely locked and past the over center. This can be done by visually inspection through the hole in the root rib both airbrake actuators must be positioned against their stops.

**BK - Antriebswelle**  
 Air brake actuating shaft

Material: See drawing no. 401-56-3-1
