GFA AIRWORTHINESS DIRECTIVE

TYPE AFFECTED: Krosno KR-03A Puchatek, serial numbers 03-01 to 03-24 and 04-01 to 04-20.

SUBJECT: Visual inspection of tailplane (horizontal stabilizer) attachment fitting.

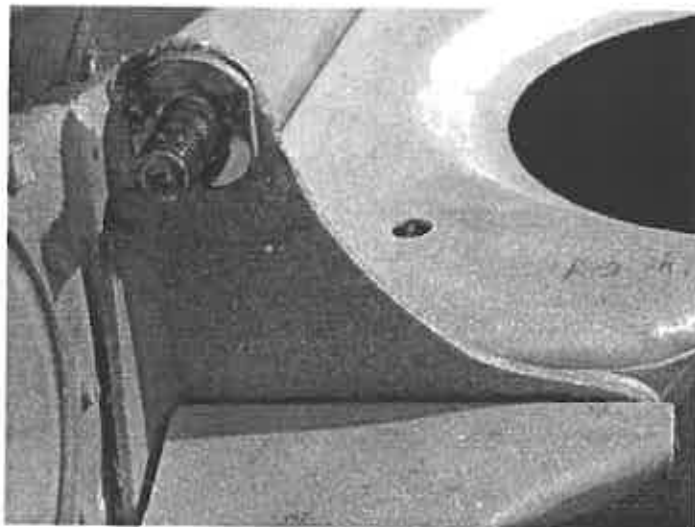
Figure 1. **Part No. NS-03/08/93-01 L/P**

This is the component that **should be** installed on the Krosno KR-03A sailplane. It can be identified by measuring the material thickness in Fig. 1 and verifying a measurement of 3 mm.

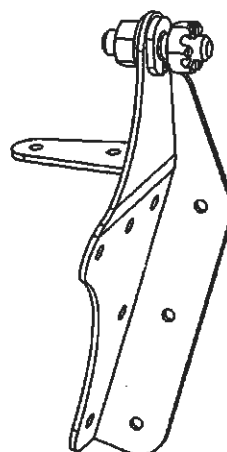
Figure 2. **Part No. AB.14.004.00.11/21**

This is the component that **may be** installed on the Krosno KR-03A sailplane. It can be identified by measuring the material thickness in Fig. 2 and verifying a measurement of 1.5 mm. If this component is installed on the Krosno KR-03A, follow the instructions contained in **WSK "PZL-KROSNO" Service Bulletin BE-29/KR-03A/93.**

2. If an incorrect fitting has been installed, replacement of the stabilizer attachment fittings is required before the next flight. Follow the KROSNO Service Bulletin BE-29/KR-03A/93. Notify Barry Aviation LLC, of your findings, with the serial number and time in service for sailplane and current owner/operator contact information. This will permit us to update our records and provide timely communication and product support. For your convenience, you can provide this information over our web site www.barryavation.com. Please specify your preference for shipping with specific instructions for replacement parts. Make an appropriate entry in sailplane's permanent record and return to service.
