GFA AIRWORTHINESS DIRECTIVE

TYPE AFFECTED: H-205 Club Libelle;
H-206 Hornet and Hornet C

SUBJECT: Rudder gimbal drive, rear actuator arm.

Flight Controls - Rudder gimbal drive - rear actuator arm

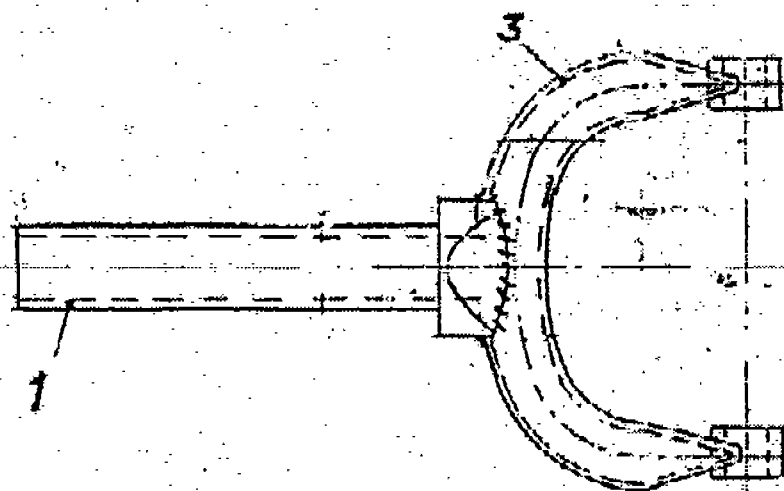
Im WIG-Verfahren mit Zusatzwerkstoff 1.7734.2 geschweißt. Grundiert mit Wash-Primer 42002 + Härter 40018. Decklackierung mit Nitro-Lack schwarz 43002.

Spannungsfrei gegläht
bei 580°C 4 std.
unter Schutzgas

- 1 off rudder actuator arm made according to drawing 203-45-10-2
1 off M4 stop nut
3 off Split pins, 1.5 x 18 mm

Replacing the actuator arm must be done by Hansjörg Streifeneder Glasfaser-Flugzeug-Service GmbH only or by an approved repair station.
Only genuine parts made in accordance with drawing No. 203-45-10-2 must be used.
Proper accomplishment of the action must be entered into the sailplane log book by a licensed inspector.
