GFA AD 599
(ISSUE 2)

GFA AIRWORTHINESS DIRECTIVE

SUBJECT: In flight failure of wing structure. Issue 1 of this AD temporarily grounded the above aircraft while investigation of the cause was carried out.

SUBJECT: Wing,
bonding of spar cap to spar web

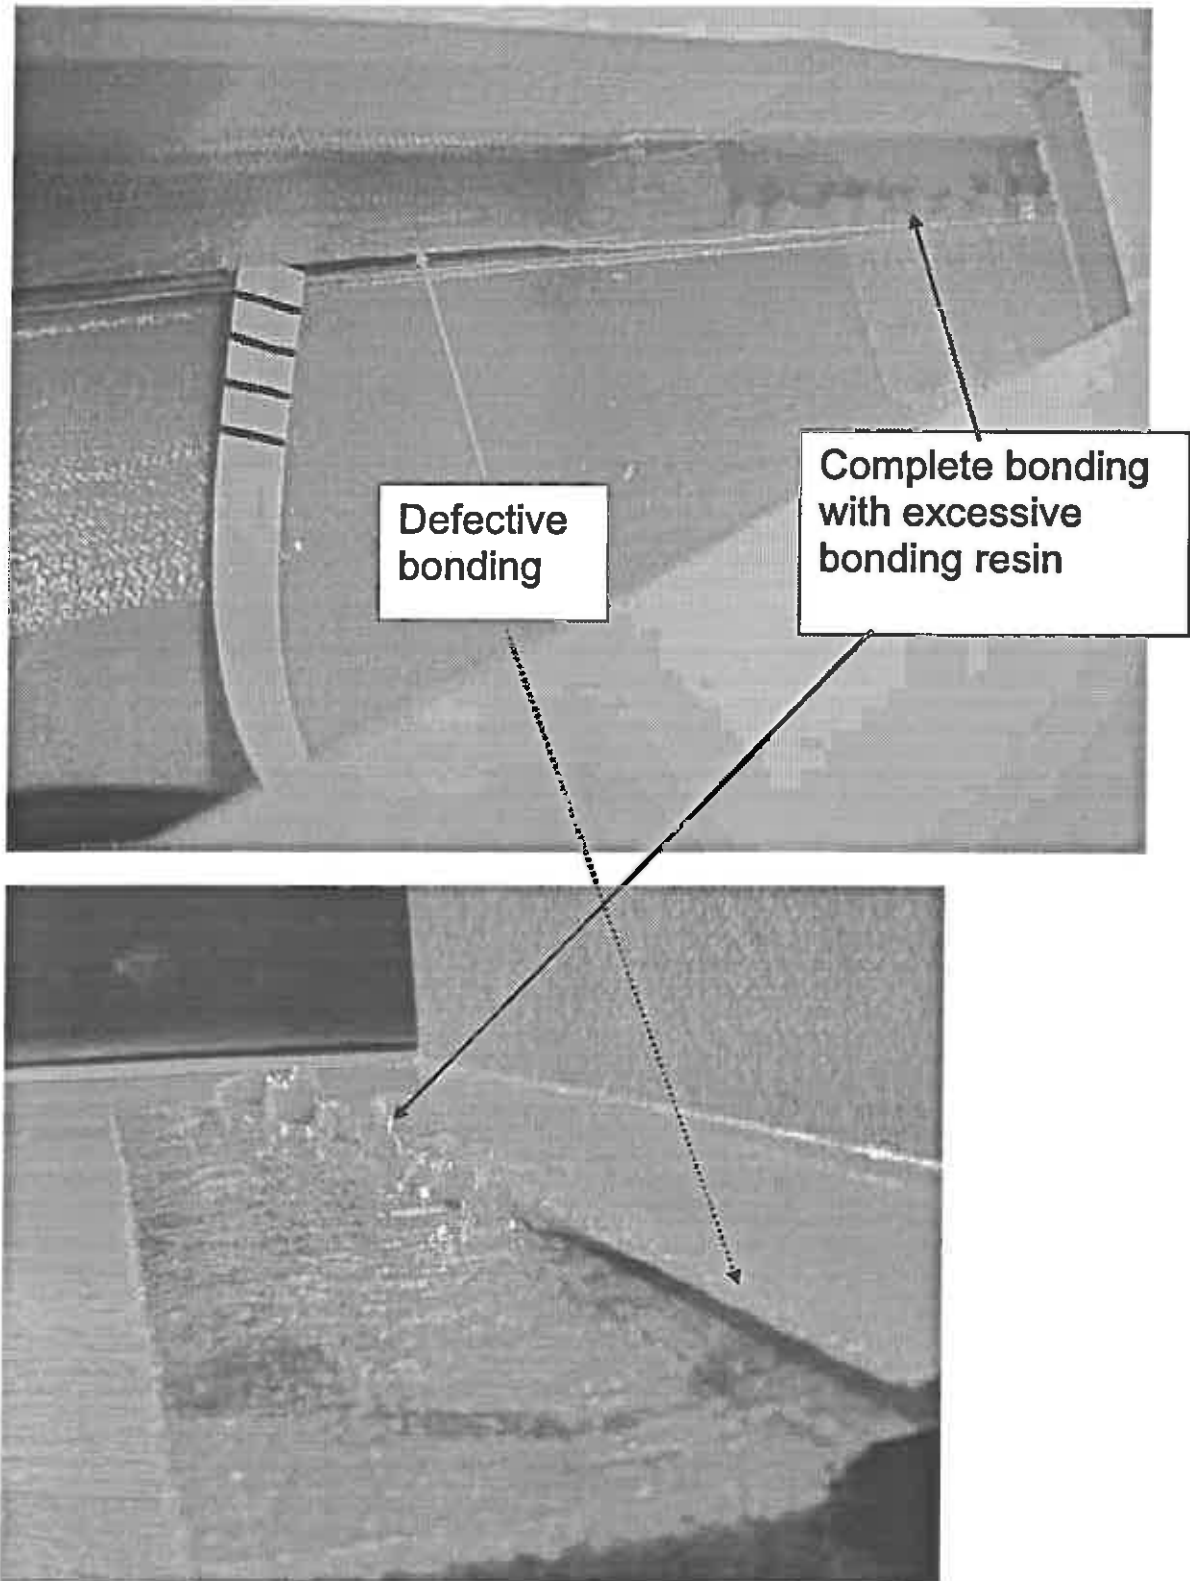
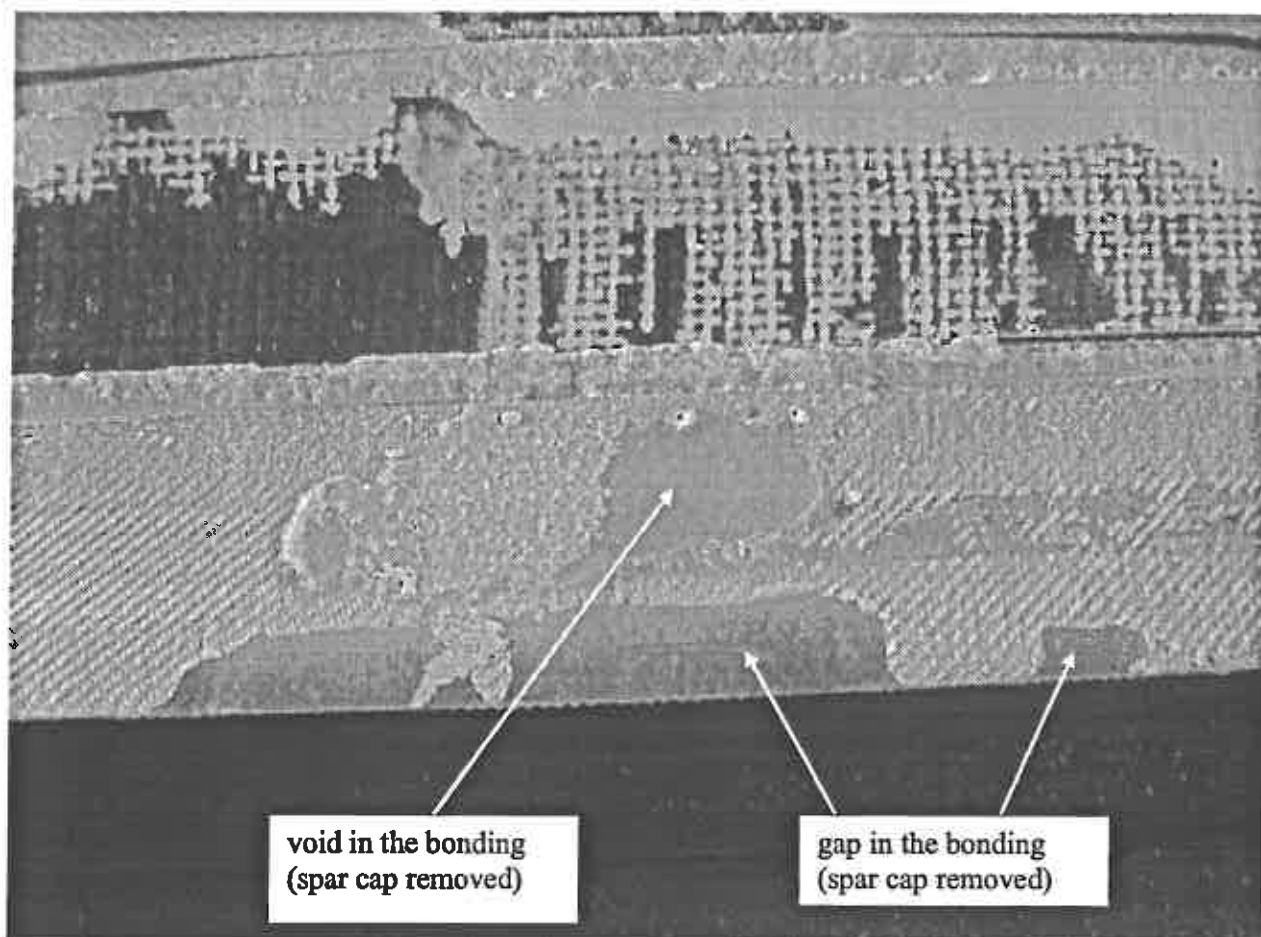
Showcase photos on page 9 and 10 indicate the following:

- a complete bonding with excessive bonding resin, see page 9
- a defective bonding – insufficient bonding resin, see page 9 and 10

When identifying the area of the gap, always investigate the extension of the void in span wise direction. Some photos on page 9 and 10 show examples of defects in the bonding.

Defects have to be repaired according the instructions on page 4 and 5.
