GFA AIRWORTHINESS DIRECTIVE

TYPE AFFECTED: DISCUS

SUBJECT: Jamming of Elevator caused by loose mass balance weights.

SUBJECT: Elevator, fixing of mass balance weights

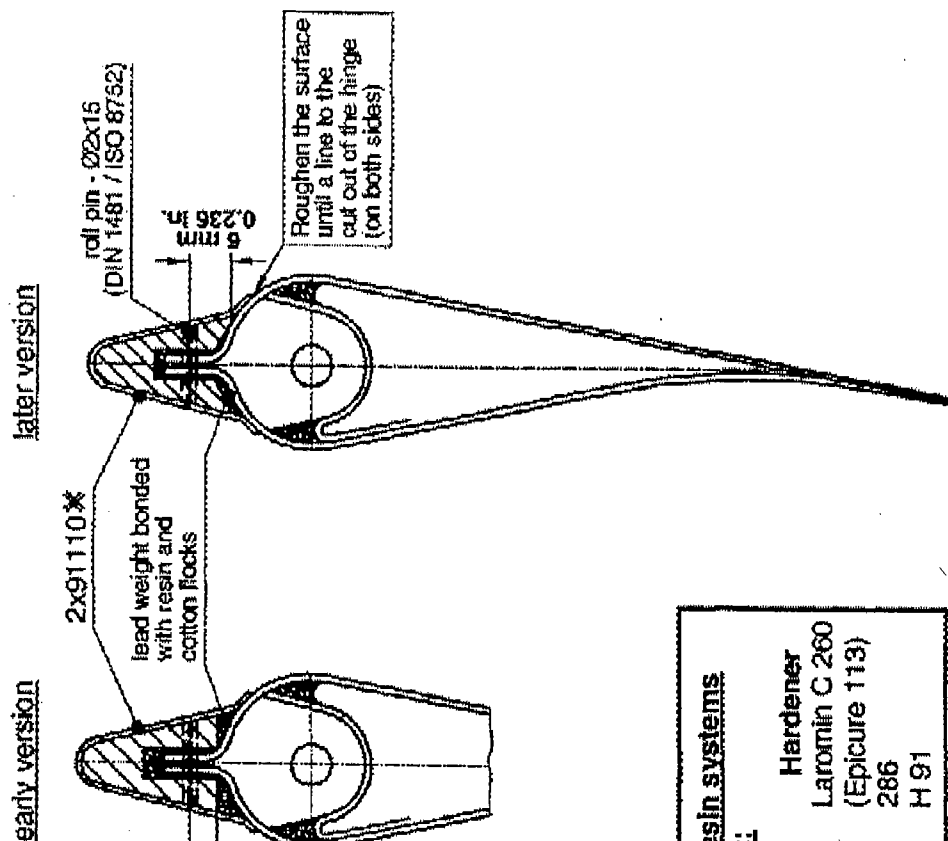
Outer lead weight

BACKGROUND: During a Daily Inspection a roughness of the elevator control was noticed. This was traced to the tailplane and on removal of one of the elevators two loose pieces of lead were found. The outermost mass balance weight had separated from the leading edge of the elevator and was broken into two pieces.

3. If the lead pieces are solidly fixed with resin and roll pins:
 - a) At the inboard lead pieces roughen the visible gaps and fill the gaps flat with resin thickened with cotton flocks.
 - b) At the outboard lead piece roughen the gap between lead and a line on the elevator, see sketch on page 2 and roughen the surface of the lead.
 - c) Fill the gaps flat with resin with cotton flocks and apply two layers of glasfibre on the lead, see sketch on page 2.

4. If a lead piece is not solidly fixed anymore (loose):
 - a) Remove the roll pins.
 - b) Roughen all bonding surfaces of the lead and elevator.
 - c) Attach the lead piece with resin with cotton flocks and take care that the gaps to the elevator are flat filled.
 - d) Apply additional glasfibre on the outboard lead piece, see item 3c.
 - e) After curing of the resin mount the roll pins again (drill new 2 mm holes) and grind the roll pins flat.
 - f) Determine the residual moment.
If the residual moment is outside the limit ask the manufacturer for instructions.
