GFA AD 604
(ISSUE 1)

GFA AIRWORTHINESS DIRECTIVE

TYPE AFFECTED: DG-500MB. Serial No: All S/N up to 5E220 B15
S/N 5E236 B16 and 5E 237 B17: Optional
S/N 5E241 B18: During production

SUBJECT: Electrical System, Extension/retraction of spindle drive.

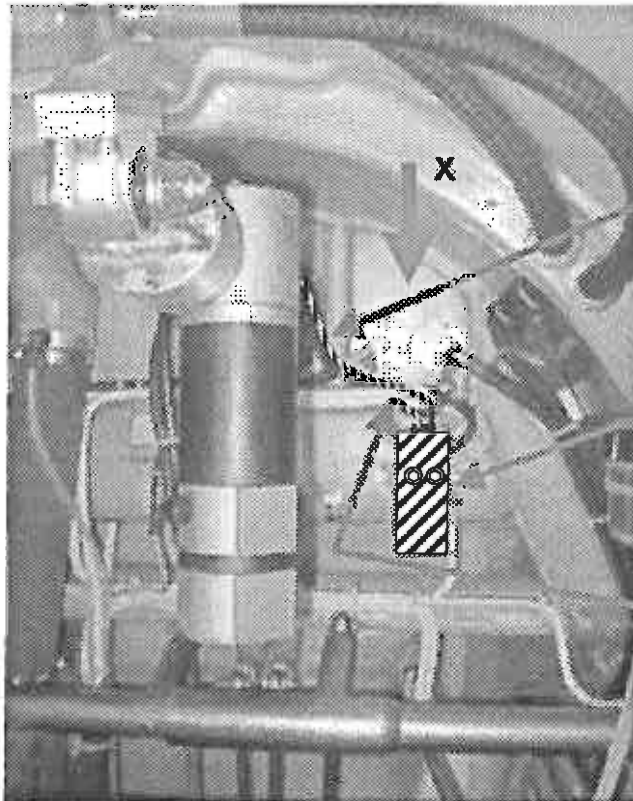
sketch 1: Attachment of the voltage converter on the fire wall (rear baggage compartment wall removed)

Connection of the power supply of the additional brake (wires 833 and 843)

Installation of the voltage converter on the fire wall (Take care to provide sufficient clearance between the bolts and the parts of the coolant system!)

Connection of the power supply for the voltage converter (wires 832 and 842)

7. Fix the voltage converter to the fire wall with bolts M4x45 DIN933-8.8zn according to sketch 1. For this purpose drill two holes Ø4mm in the fire wall. If the fire wall is not flush in the contact area of the voltage converter this must be corrected. Mark and sand carefully the contact area on the fire wall and put some cotton flock resin between fire wall and voltage converter (add some releasing agent to the converter housing!) Attention: Choose the position of the voltage converter in a way so that after installation the bolts do not interfere with the coolant pump or the coolant lines in the engine compartment. If necessary shorten the bolts accordingly. Also take care that when drilling the holes Ø4mm neither the coolant pump nor the coolant lines in the engine compartment are damaged.
