GFA AIRWORTHINESS DIRECTIVE

TYPE AFFECTED: PW-5 Serial no.s 17.12.022 to 17.12.024

SUBJECT: Inspection of push rod ends installed in aileron and spoiler drives.

No. BO-17-03-18

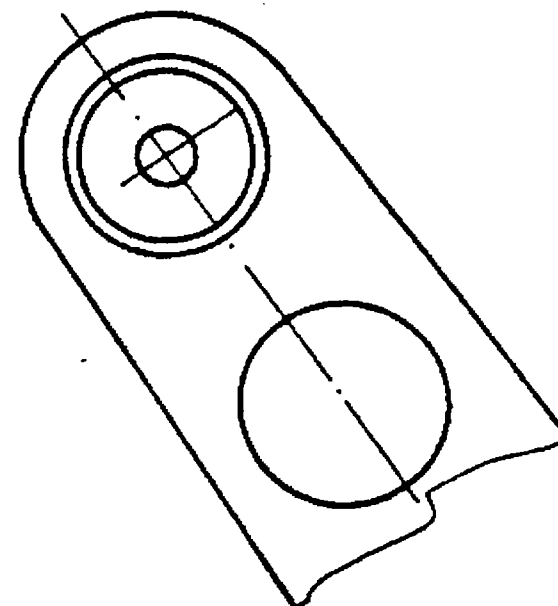
Sketch 1: Push-rod end

In relation to a case of exceeding the minimum dimension of the push-rod end S/N 511.00.20.00, it is required to make the measurement of all ends installed in the PW-5 sailplane in accordance with the Sketch No. 1 enclosed to this bulletin. The ends are installed in wings in the aileron control system and in the air brakes (altogether 4 pcs per sailplane).

This bulletin is intended to advise the PW-5 sailplane operators that if the dimension defined on the sketch is found to be less than 4.2 mm, the flights should be discontinued and the sailplane must be parked until a particular push-rod end is replaced with a new one.

The activities related with measurement of ends shall be performed by the sailplane operator. In case the measured parameter is less than the acceptable one, a new end must be ordered. For this purpose, send the following information to „PZL-Świdnik” S.A onto the fax No.(+48 81) 468 09 18: sailplane S/N, location of the end installation and measurement result. This shall be the basis for the free-of-charge ordering of a new end at „PZL-Świdnik” S.A. The sailplane manufacturer shall deliver, at his own expense, the new ends S/N 511.00.20.00 and the retaining washers preventing the ends against loosening. The ends shall be replaced with new ones by the operator at his own expense.
