GFA AIRWORTHINESS DIRECTIVE

- TYPE AFFECTED:** GROB ASTIR CS. Type Cert 306. Ser No's 1001 up to 1536
- SUBJECT:** Horizontal stabilizer: Inspection & replacement of spherical head mounting bolt and collar bolts.

SERVICE BULLETIN MSB306-38/2

SERVICE BULLETIN NO. MSB306-38

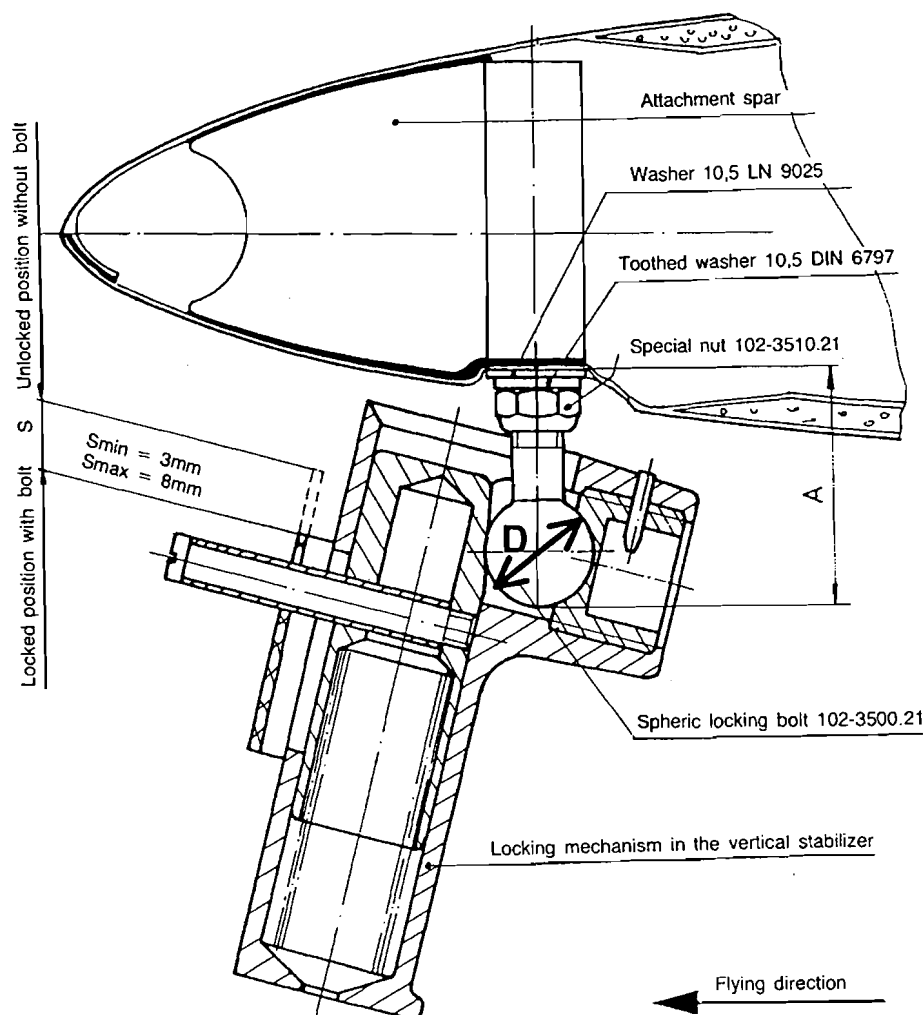
An incident was reported, where the spherical locking bolt of the horizontal stabilizer attachment was broken after landing. The investigation has proved a fatigue crack caused by alternating stress on to the stabilizer with unsymmetrical loads. This fatigue failure could have been caused by various external influences. To prevent further incidents the inspection of the front and rear vertical stabilizer attachment and especially an inspection of the spherical bolt P/N 102-3500.21 is mandatory.

1.8.2 Inspect and replace the spherical locking bolt as follows:

- remove horizontal stabilizer according to the Flight Manual and lay down in a proper device
- determine and note the exact installation depth "A"

- loosen the hexagon nut P/N 102-3510.21 (14 mm wrench) and remove spherical bolt using a screw driver
- inspect the thread of the bolt (especially in the area nut/ socket) for cracks or damage (using magnifying glass x20 or dye penetrant testing)
- if a crack or any indication for crack starting is found, the bolt must be replaced immediately

- install the inspected or new spherical bolt, thereby pay attention for the correct installation depth
- tighten hexagon nut P/N 102-3510.21 with torque 20 Nm (tolerance +4, -2) holding the bolt using a screw driver
- install horizontal stabilizer
- check and adjust if necessary the stabilizer angle of incident according to the Flight Manual
