**GFA AD 610**  
(ISSUE 1)

**GFA AIRWORTHINESS DIRECTIVE**

- TYPE AFFECTED:** DG-800B Serial No.s: All, up to 8-321 (Solo & MidWest engines)  
DG-500M Serial No.s: All. DG-500MB Serial No.s: All up to 5E243.
- SUBJECT:** Fuel leakage from Power plant Primer Valve.

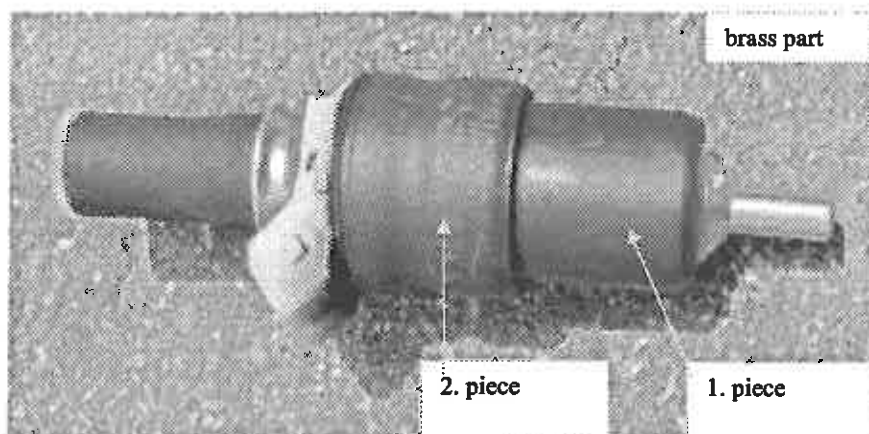
- Reason** : On a DG-800B the brass part of the primer valve disintegrated from the valve and fuel was spilt.
- Instructions** : 1. Pull with your hand at the brass part of the primer valve to see if it is still fixed to the valve. If the part is loose, instruction 3 must be accomplished prior to the next powered flight.

2. Dismount the pipe clamp which holds the primer valve. Remove the fuel line from the brass part of the valve. Clean and degrease the outer surface of the valve. Cut a piece 55mm (2.2 in.) long from the heat shrink tubing. Slip the tubing over the brass and the black plastic part of the valve body. Use a hot air gun (min. 200°C, 390°F) to heat the tubing until it shrinks and gives a tight fit, see photo.  
It is possible that the valve will no longer fit into the pipe clamp. In this case remove the rubber anti-chafe strip from the inside of the clamp and apply a second piece of the heat shrink tubing 25mm long, see photo.
